Rubens' 'The Watering Place'

Christopher Brown, Anthony Reeve and Martin Wyld

The treatment of the picture Anthony Reeve

Figure 2
Rubens, *The Watering Place* (No.4815), before treatment.

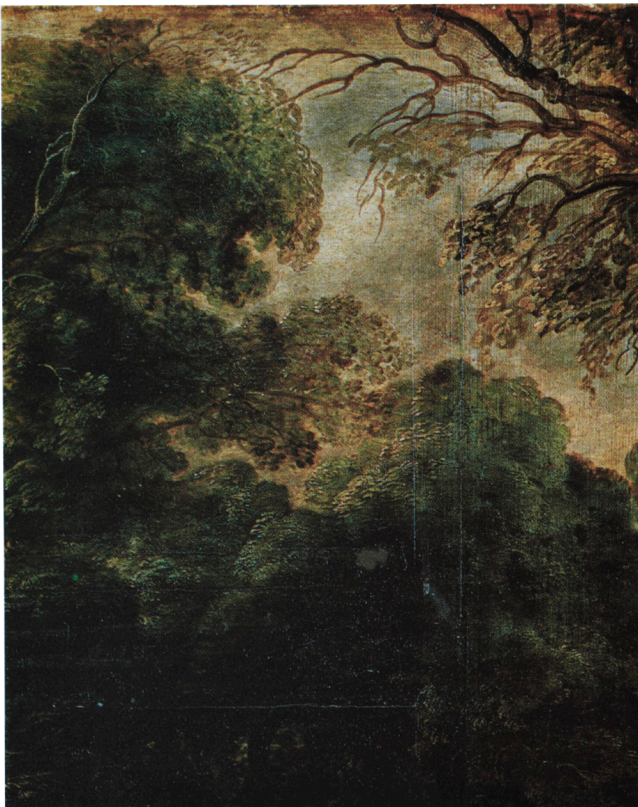
Plate 4 Rubens, *The Watering Place* (No.4815). Detail of top right corner, before cleaning.

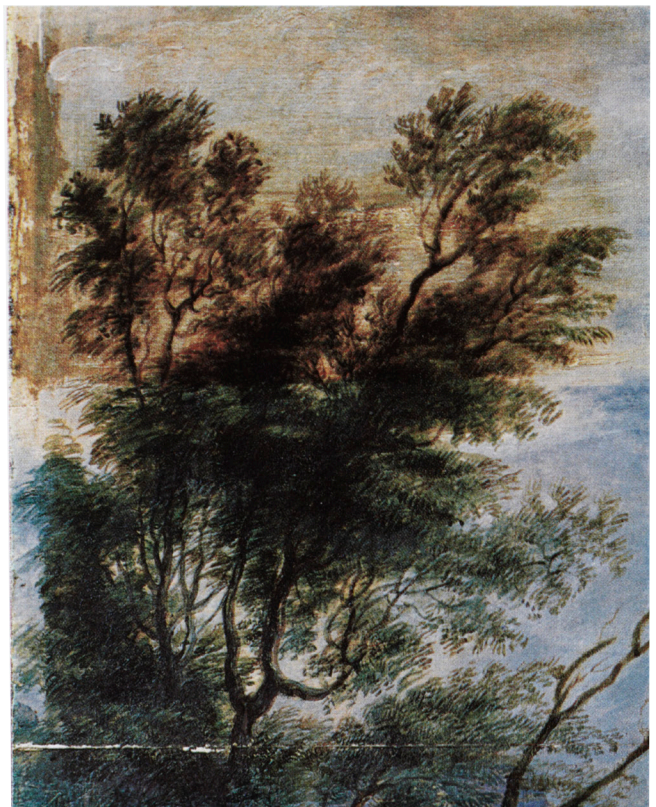
Plate 5 Rubens, *The Watering Place* (No.4815). Detail of left edge during varnish removal.

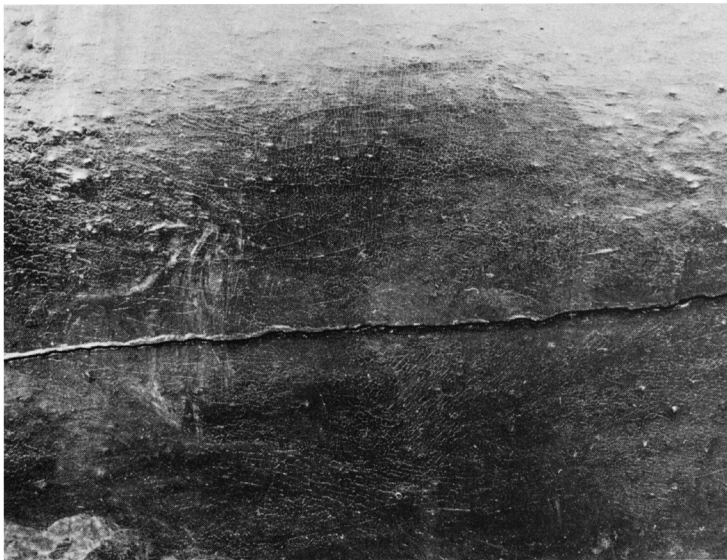
Figure 3
Detail of the split
in the middle of
the panel.

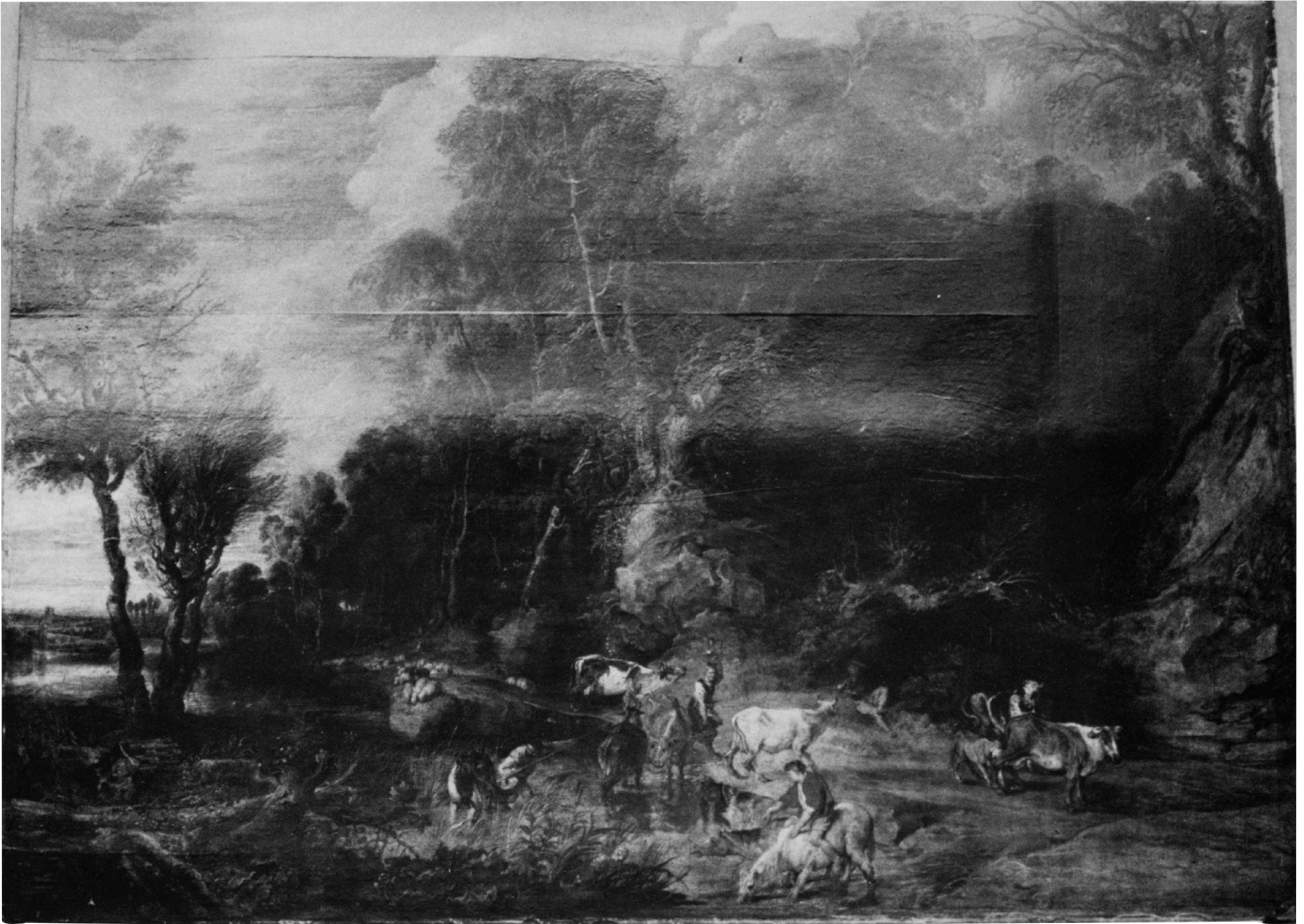
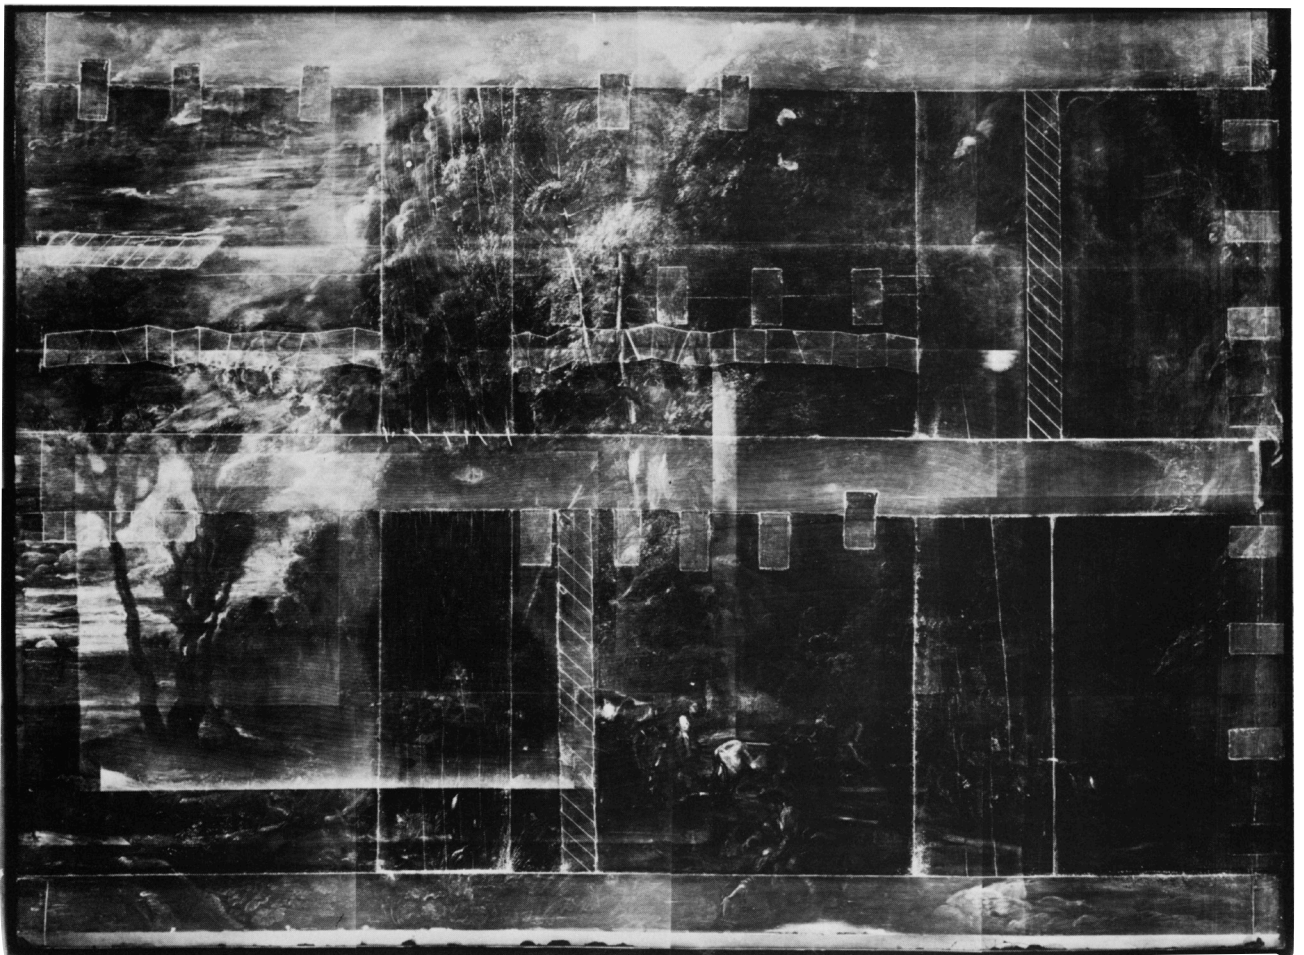
Figure 4 (Left) The whole before treatment in raking light, showing the bulge centre right and some of the surface irregularities.

Fig.4 shows both the complexity of Rubens' original panel construction and the various attempts at repair. All the small rectangular blocks of wood at the left, right and top edges, along the central horizontal plank, and the zig-zag lengths above it, are mahogany repairs made at various times to fix either splits or loose original joins.

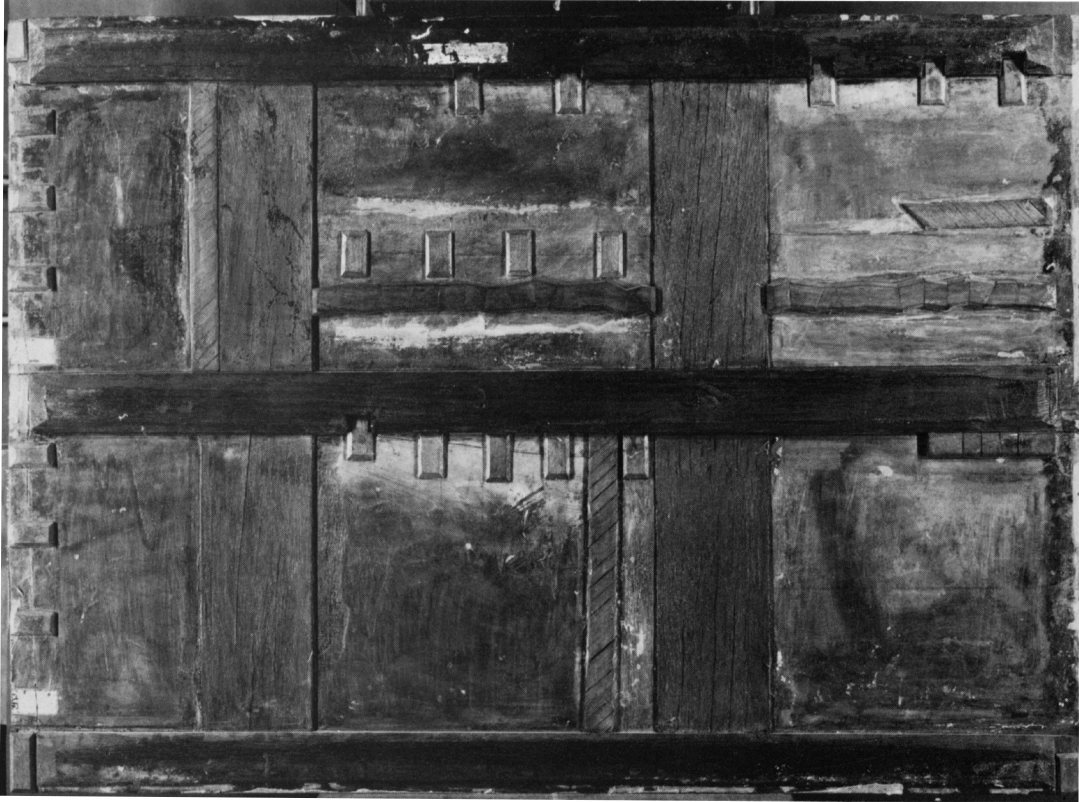
Figure 6 The back before treatment.

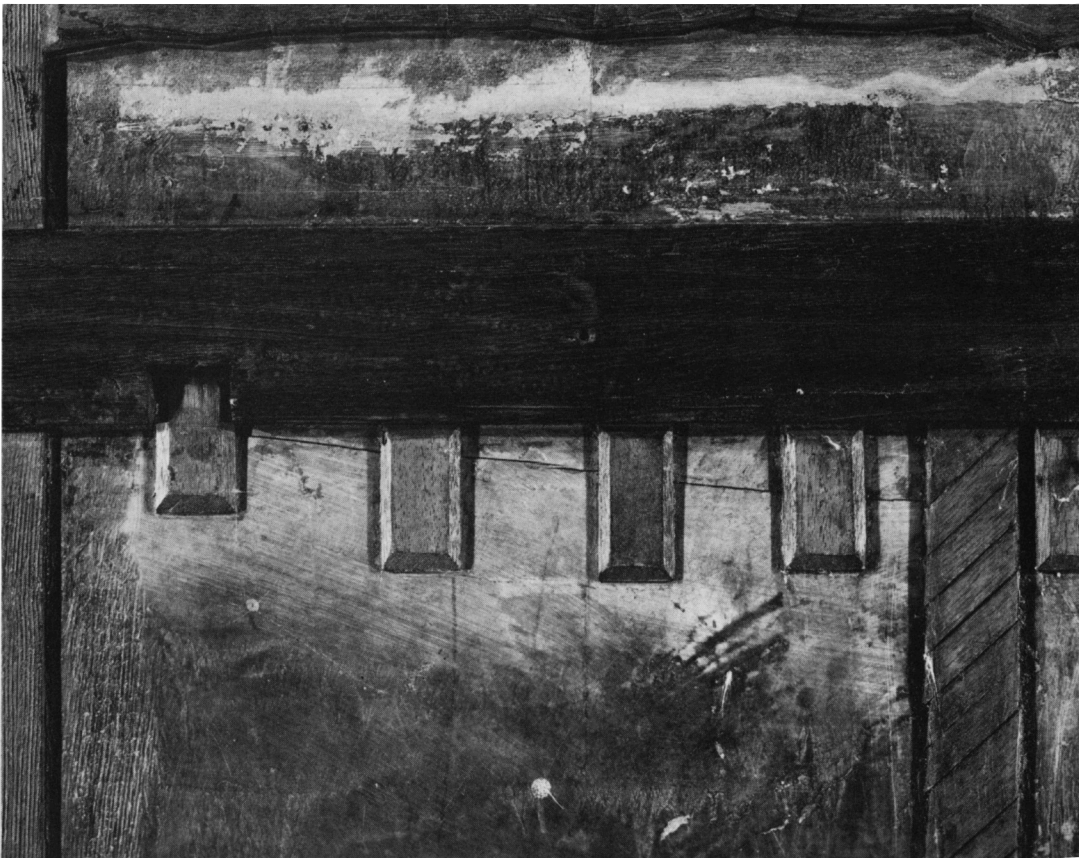
Figure 7 Detail of the middle of the back before treatment, showing the unsuccessfully repaired crack, the central horizontal batten, part of the left vertical batten, and many of the mahogany blocks.

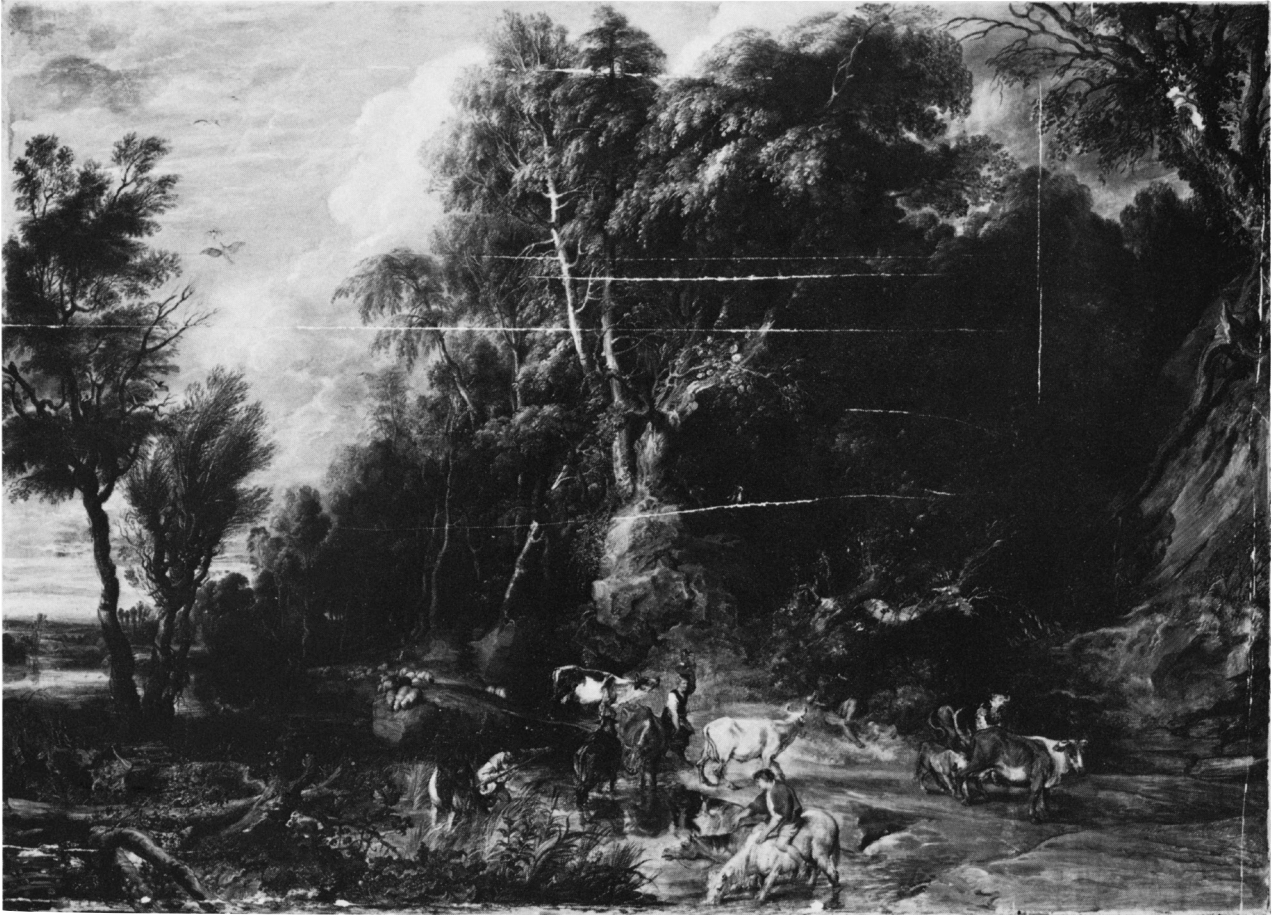
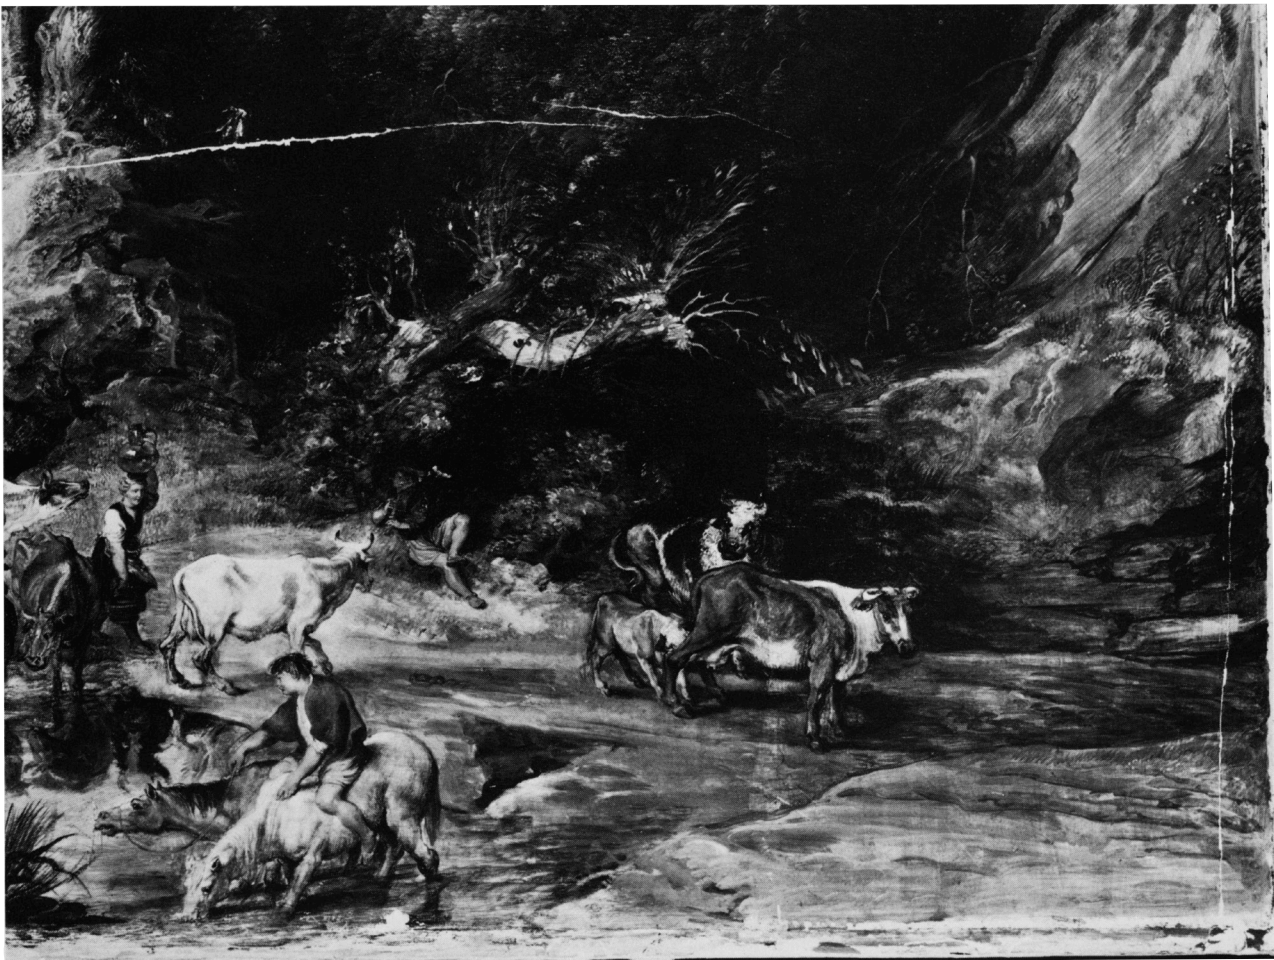
Figure 8 (Left)
The whole after cleaning and before restoration. The worst splits and repaired joins show clearly.

Figure 9 (Left)
Detail after cleaning and before restoration. This detail is of the area where the panel had bulged due to its internal stresses, and two cracks had formed.

grain of each piece runs in the same direction, is not necessarily more stable than a panel in which the planks are joined with the grain at right-angles. It is significant that there were no splits or loose joints at the left edge of *The Watering Place*, whereas all the most serious splits, and the bulge, occurred near the join of the main part of the panel and the single vertical plank on the right.

The glueing of the splits occupied several weeks, the majority of the time being spent in removing the old glue and in preparing the clamping systems so that pressure could be applied both from above, below and from the side. The central bulge in plank 7 was considerably flattened and stabilized by the treatment of the splits in it. All the panel-work was done in the Conservation Workshop, an air-conditioned room on the ground floor of the National Gallery, and hence not subject to solar heat gain. The panel was kept covered, and variations in temperature and RH were small (temperature: 67–70°F, RH: 52–57%), but the stresses inherent in a panel of such complex construction were revealed by even the slightest change in the environment. Slight convex and concave warps, both horizontal and vertical, occurred, bringing the danger of more splitting. With great reluctance a decision was made to remove the two vertical and three horizontal battens, the former being certainly part of the original construction, and the latter probably original as well. The battens also prevented proper treatment of some of the splits and of the fracture which ran all the way up the right edge (see Fig.8).

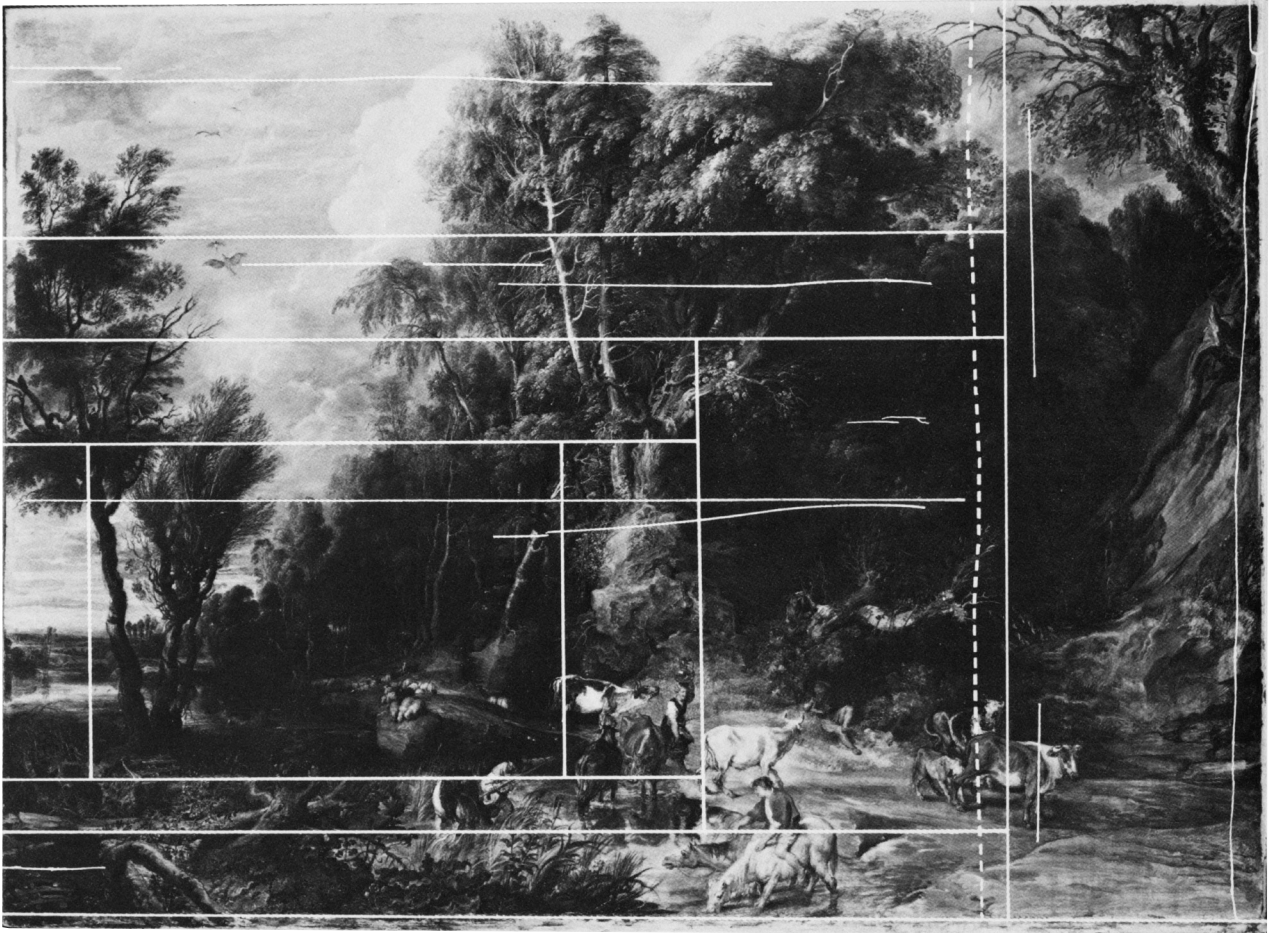
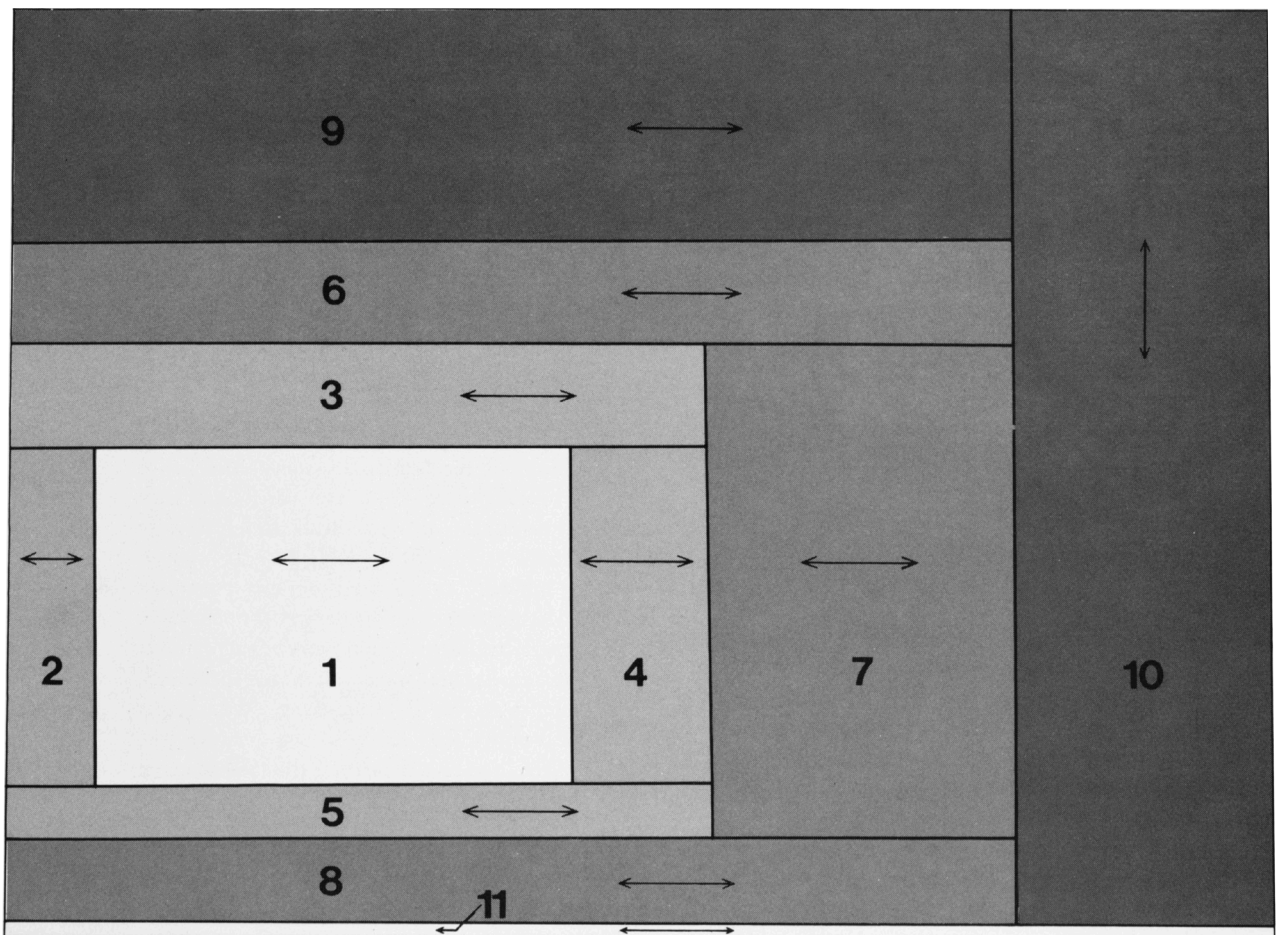
Figure 12a (Right, top) Diagram of the panel construction, omitting the battens on the back. The thinner lines show the worst of the splits; the broken line indicates a chamfered edge.

Figure 12b (Right, bottom) Diagram of the panel showing the sequence of construction (see p. 33), and direction of wood-grain.

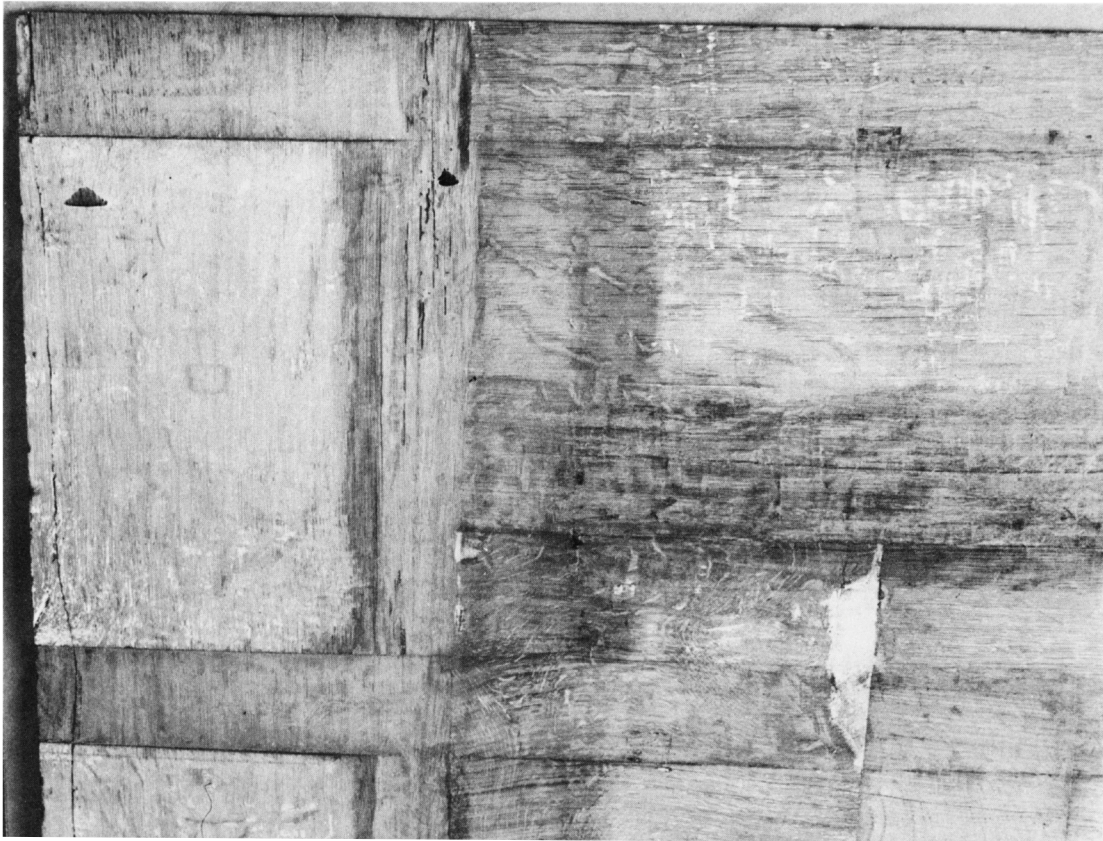
Figure 13 The back after the removal of the battens.

Figs 13,14 and 15 show the back of the panel after the battens had been removed. Although the removal of part of an original panel construction is very much a last resort, it was thought to be justified in this instance. Had the battens been allowed to remain in position, it is likely that the panel would still have been inordinately sensitive, whatever form of protection or reinforcement had been applied to the back.

The method described in the previous issue of this *Bulletin* for a panel by Cossa [3] was used to reinforce the Rubens oak panel. Briefly, two layers of balsa wood planks were attached with a wax-resin adhesive. The main principles of this method are firstly, that it is very easily reversible, and secondly, should any movement occur in the panel, the wax and balsa wood will break away, allowing the panel to warp rather than causing it to split.

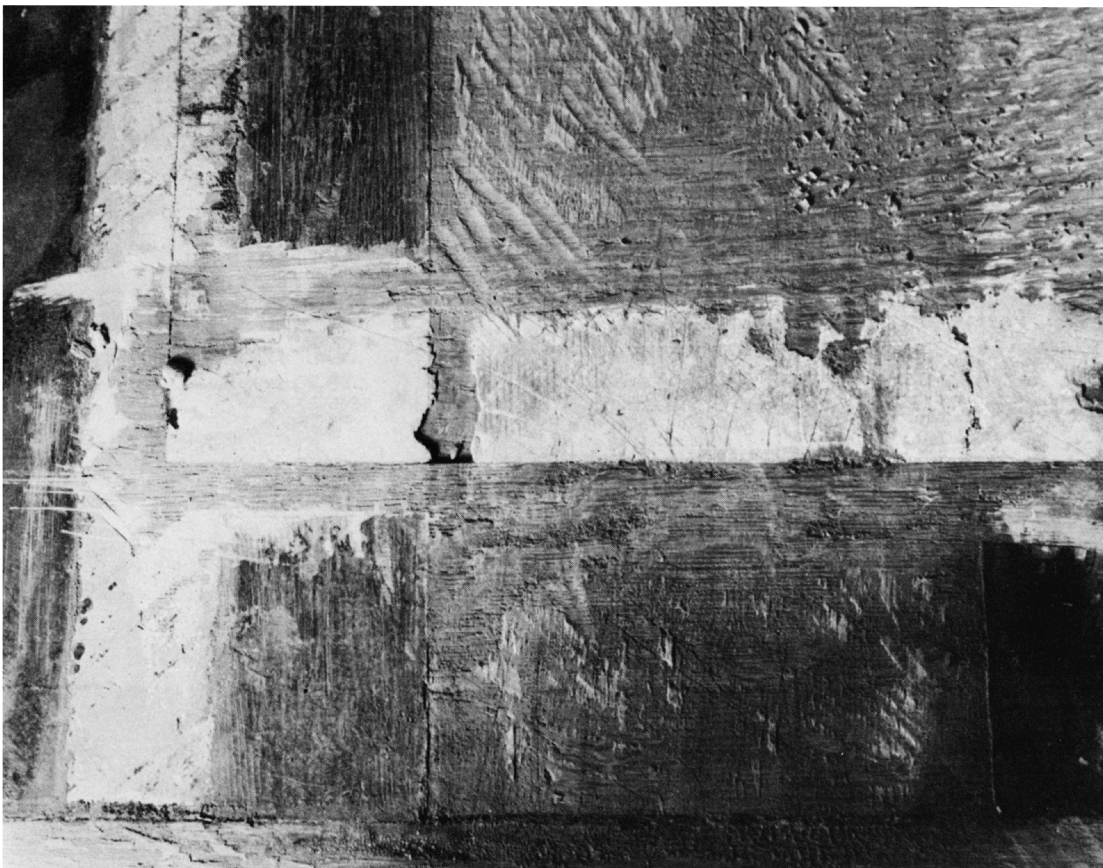
Figure 14 The top left corner of the back after the removal of the battens. The channels which were cut for the horizontal battens can be seen.
