National Gallery Technical Bulletin

Volume 9, 1985

The Transfer of Cima's 'The Incredulity of S. Thomas'

Martin Wyld and Jill Dunkerton

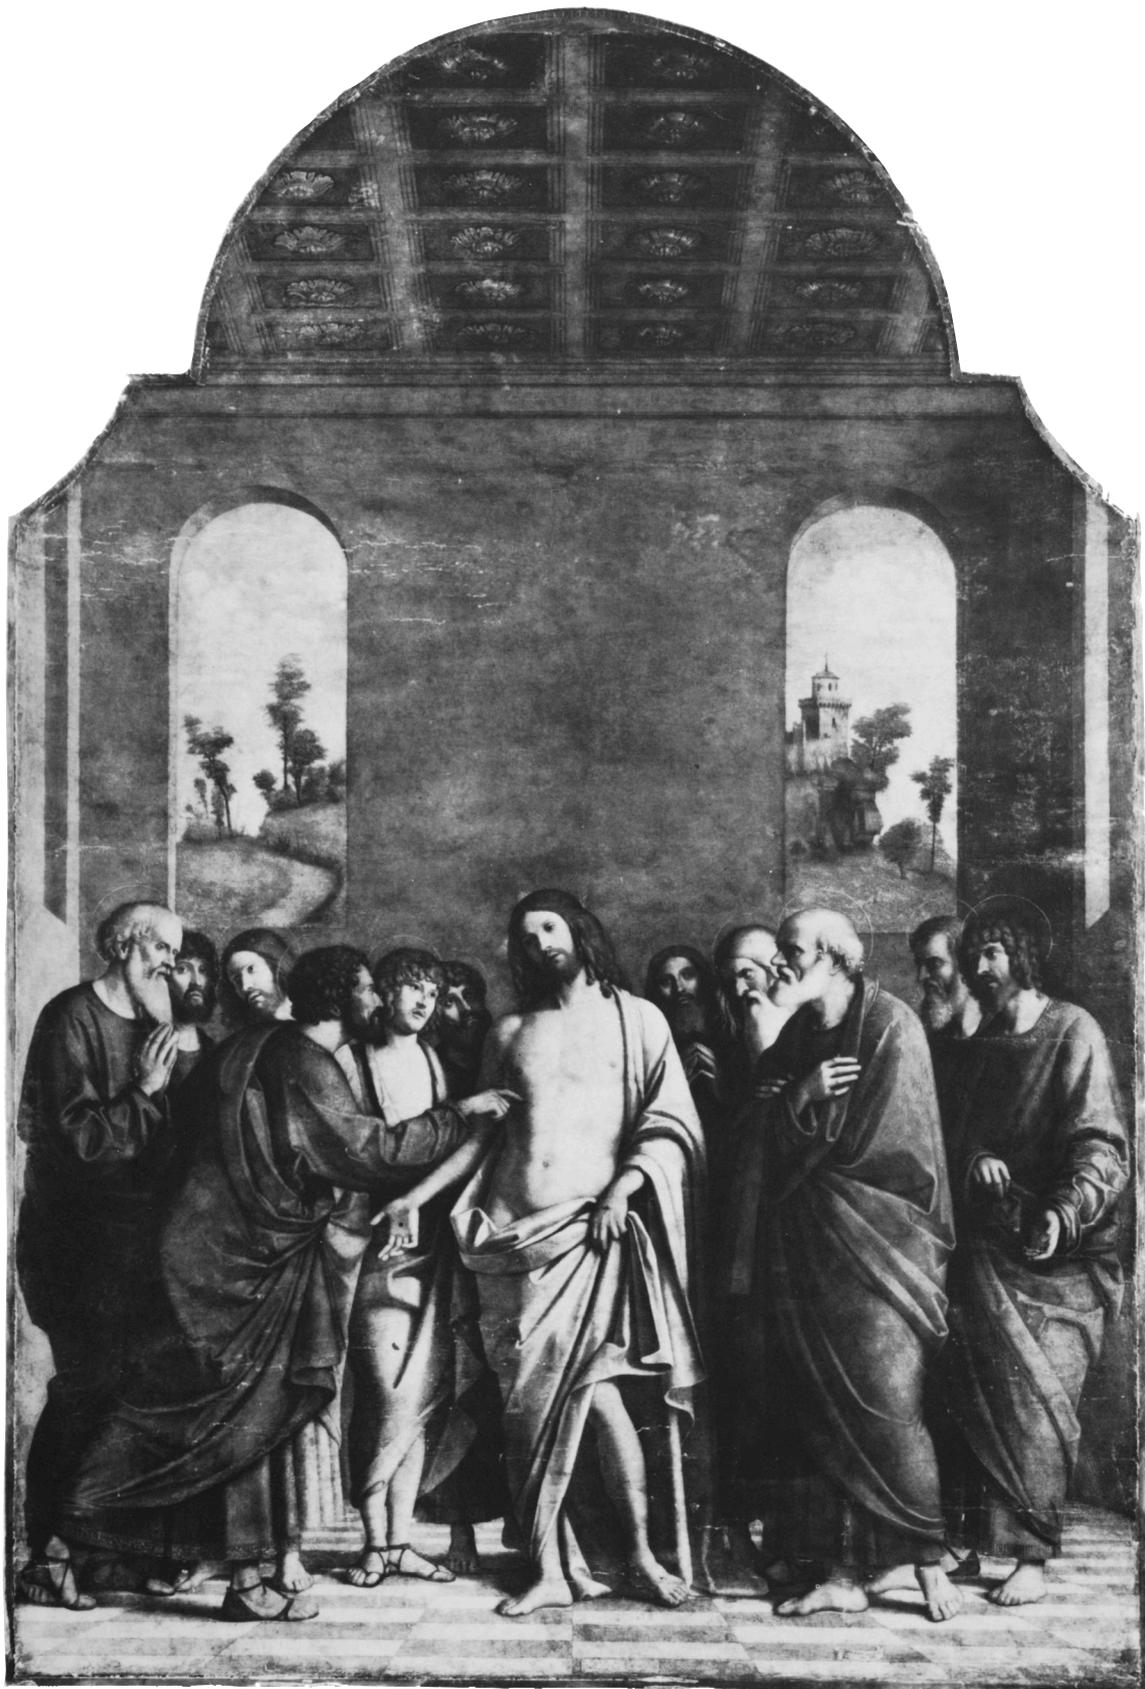
Figure 1 Cima, *The Incredulity of S. Thomas* (No. 816), 2.940 × 1.994, before treatment.

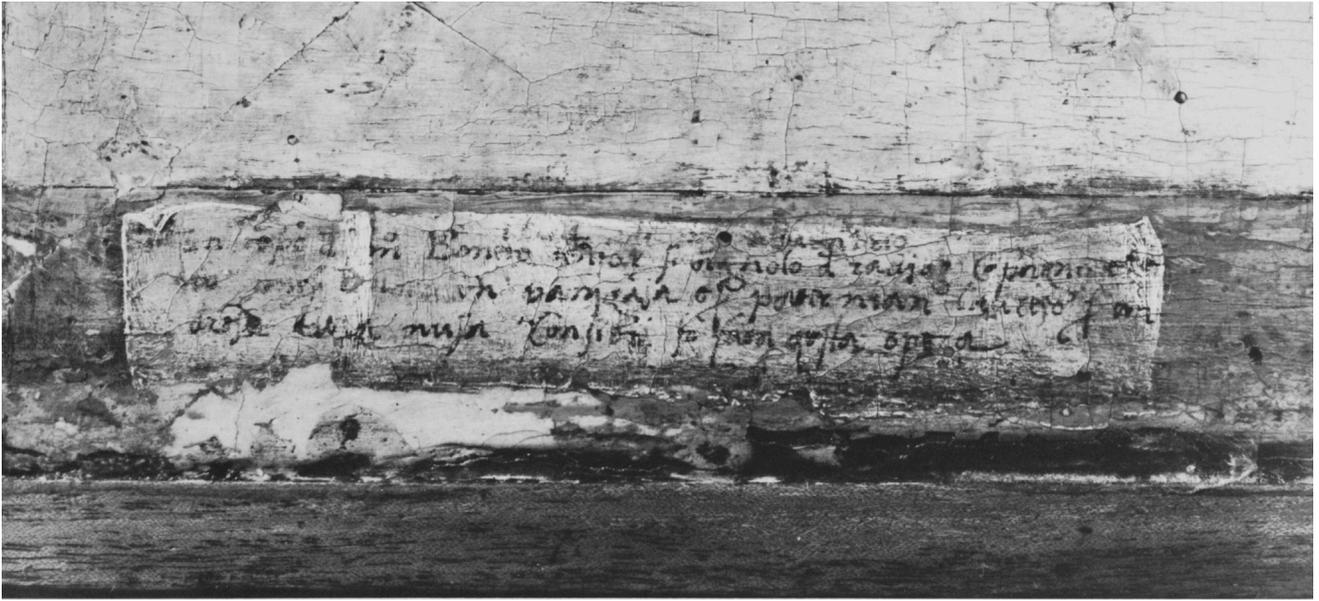
Figure 2 Detail (after cleaning, before restoration) of the *cartellino* giving the date and names of the officers of the confraternity responsible for commissioning the altarpiece.

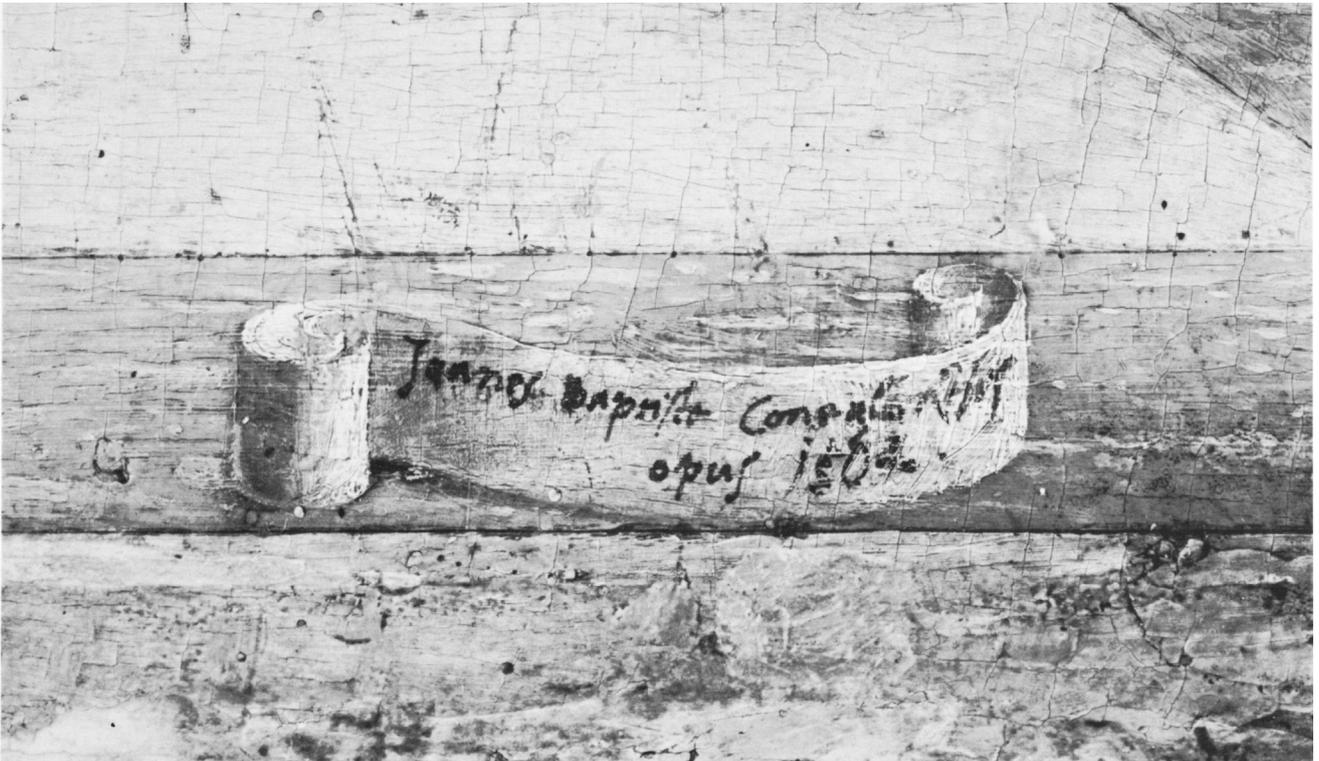
Figure 3 Detail (after cleaning, before restoration) of the *cartellino* with Cima's signature. The date has been added with black paint, as opposed to the brown used for the rest of the inscription, and may have been taken over from the other *cartellino*.

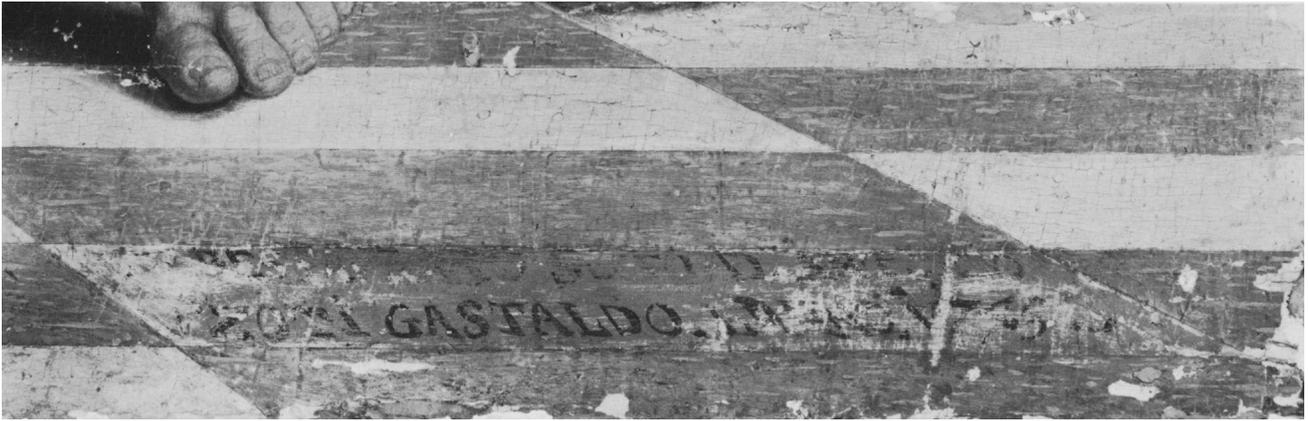
The next secure date in the physical history of the painting is 1745, when, according to a crudely painted inscription on a floor-tile in the bottom right corner (Fig.4), a restoration was carried out under 'D. ANG[el]JO ZOT[i?] GASTALDO' (that is, officer of the confraternity). This inscription, which was only uncovered in 1981 during further cleaning after the transfer had been completed, has been painted using a paint which, in its coarse texture and almost total resistance to cleaning solvents, is very like that found over some of the largest losses in the painting, including those on the robes of S. Thomas and S. Peter, the chest of the disciple on the far right, and, in particular, the very discoloured, black retouchings scattered across the back wall of the room. This suggests that the painting had suffered extensively from flaking, perhaps caused by neglect and poor environmental conditions, but also possibly because of a technical fault in the preparation of the panel, for example either too much or too little size brushed onto the panel before the application of the gesso layers [9].

Figure 4 Detail (after further cleaning, before restoration) of the inscription recording a restoration carried out in 1745.

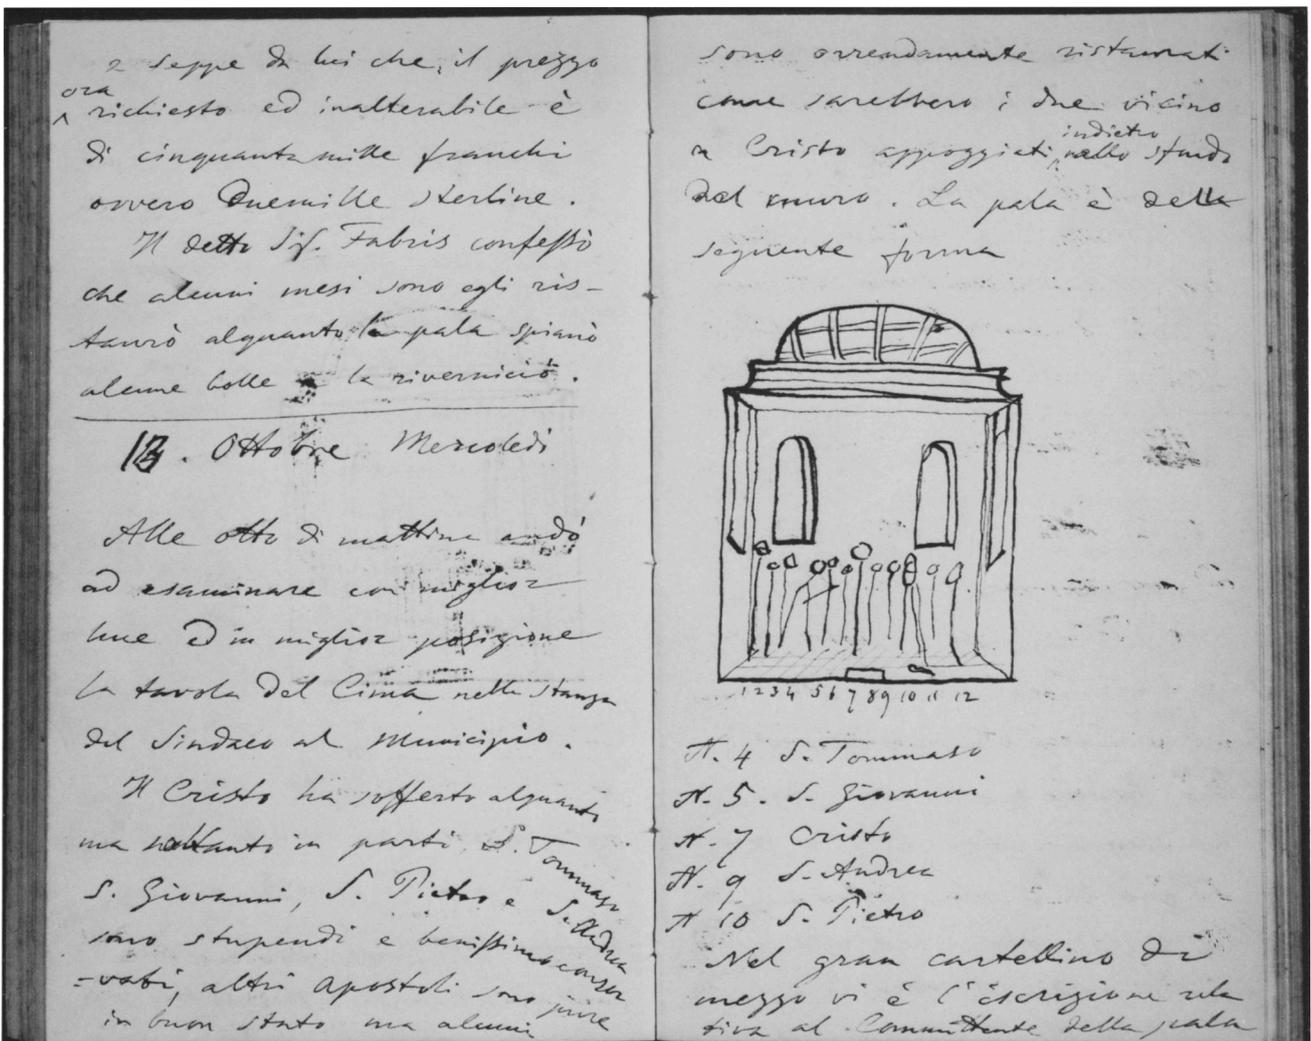
Figure 5 Two pages from the notebook in which William Boxall described the condition of the altarpiece when he saw it in Portogruaro in 1869. National Gallery Archive.

S. Andrew [identified as the figure to the left of S. Peter] are stupendous and very well-preserved, other apostles are also in a good state, but others are horrendously restored like the two close to Christ.' [21] (Fig.5)

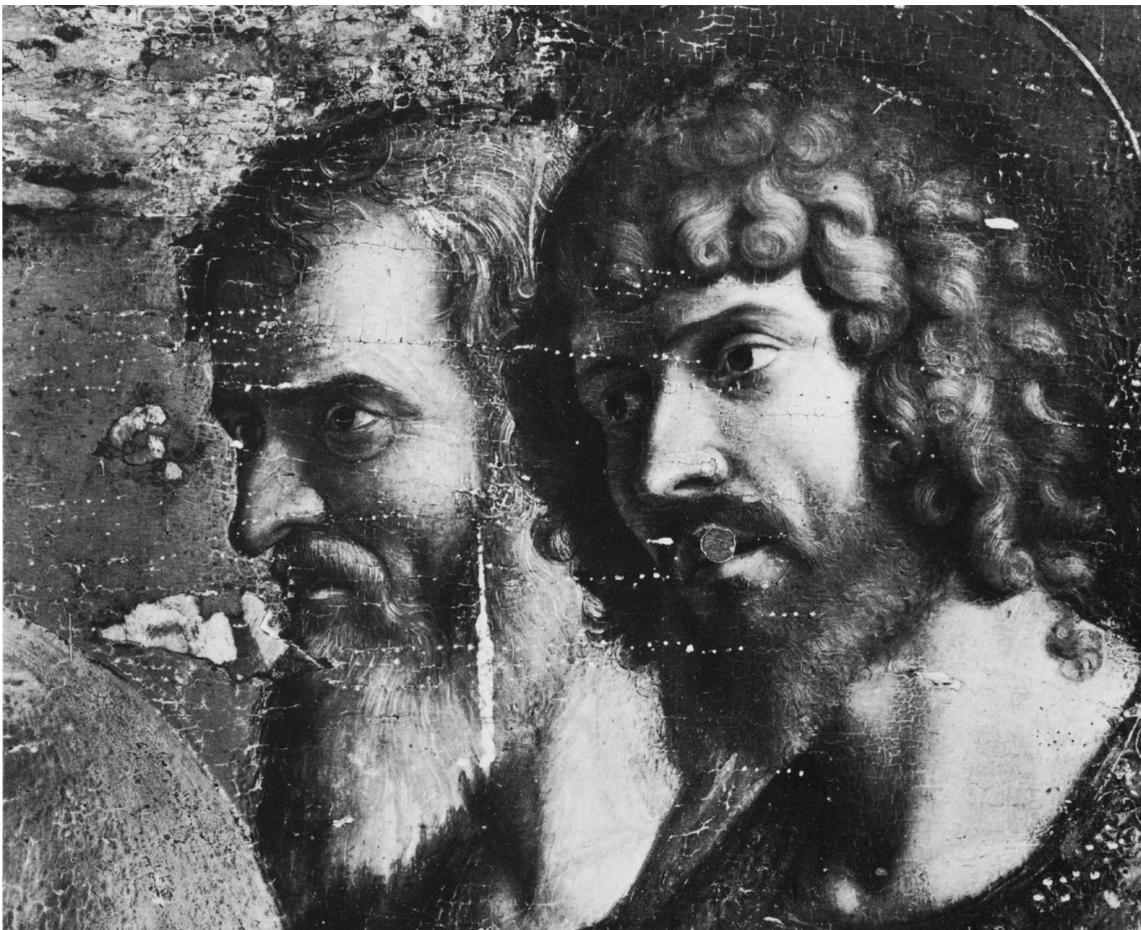
Figure 6 Two Apostles' heads during cleaning. This is a well preserved area, with a typical number of injection holes.

The photographs taken at this time (Figs.6 and 7, Plate 10, p.47) show the condition of the paint surface as regards loss, wearing, holes made during early attempts at blister-laying by injection, and the many different coloured and textured fillings used, but not its extreme fragility. It was by now clear that blister-laying alone would never consolidate the surface sufficiently to allow the picture to be exhibited. Because the paint and gesso formed one mainly continuous layer, Lucas decided that they could be transferred to a new support, and this proposal was accepted. As Lucas has pointed out [2], had

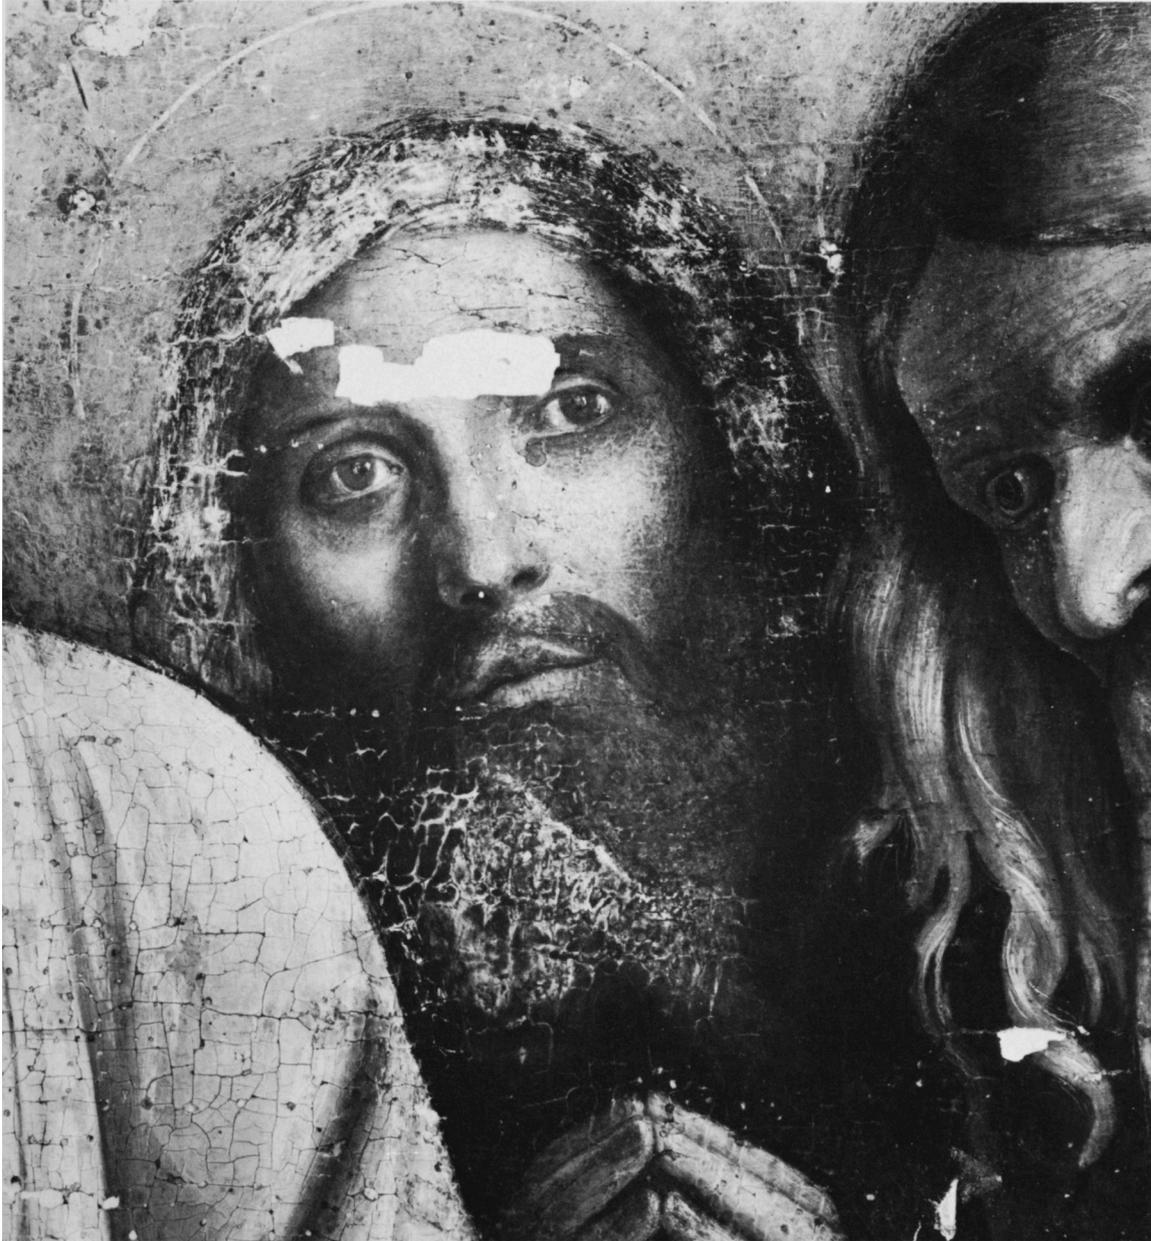
Figure 7 The Apostle to the right of Christ during cleaning. The abrasion of the paint in the beard and hair was probably caused by vigorous blister-laying with a very hot implement.

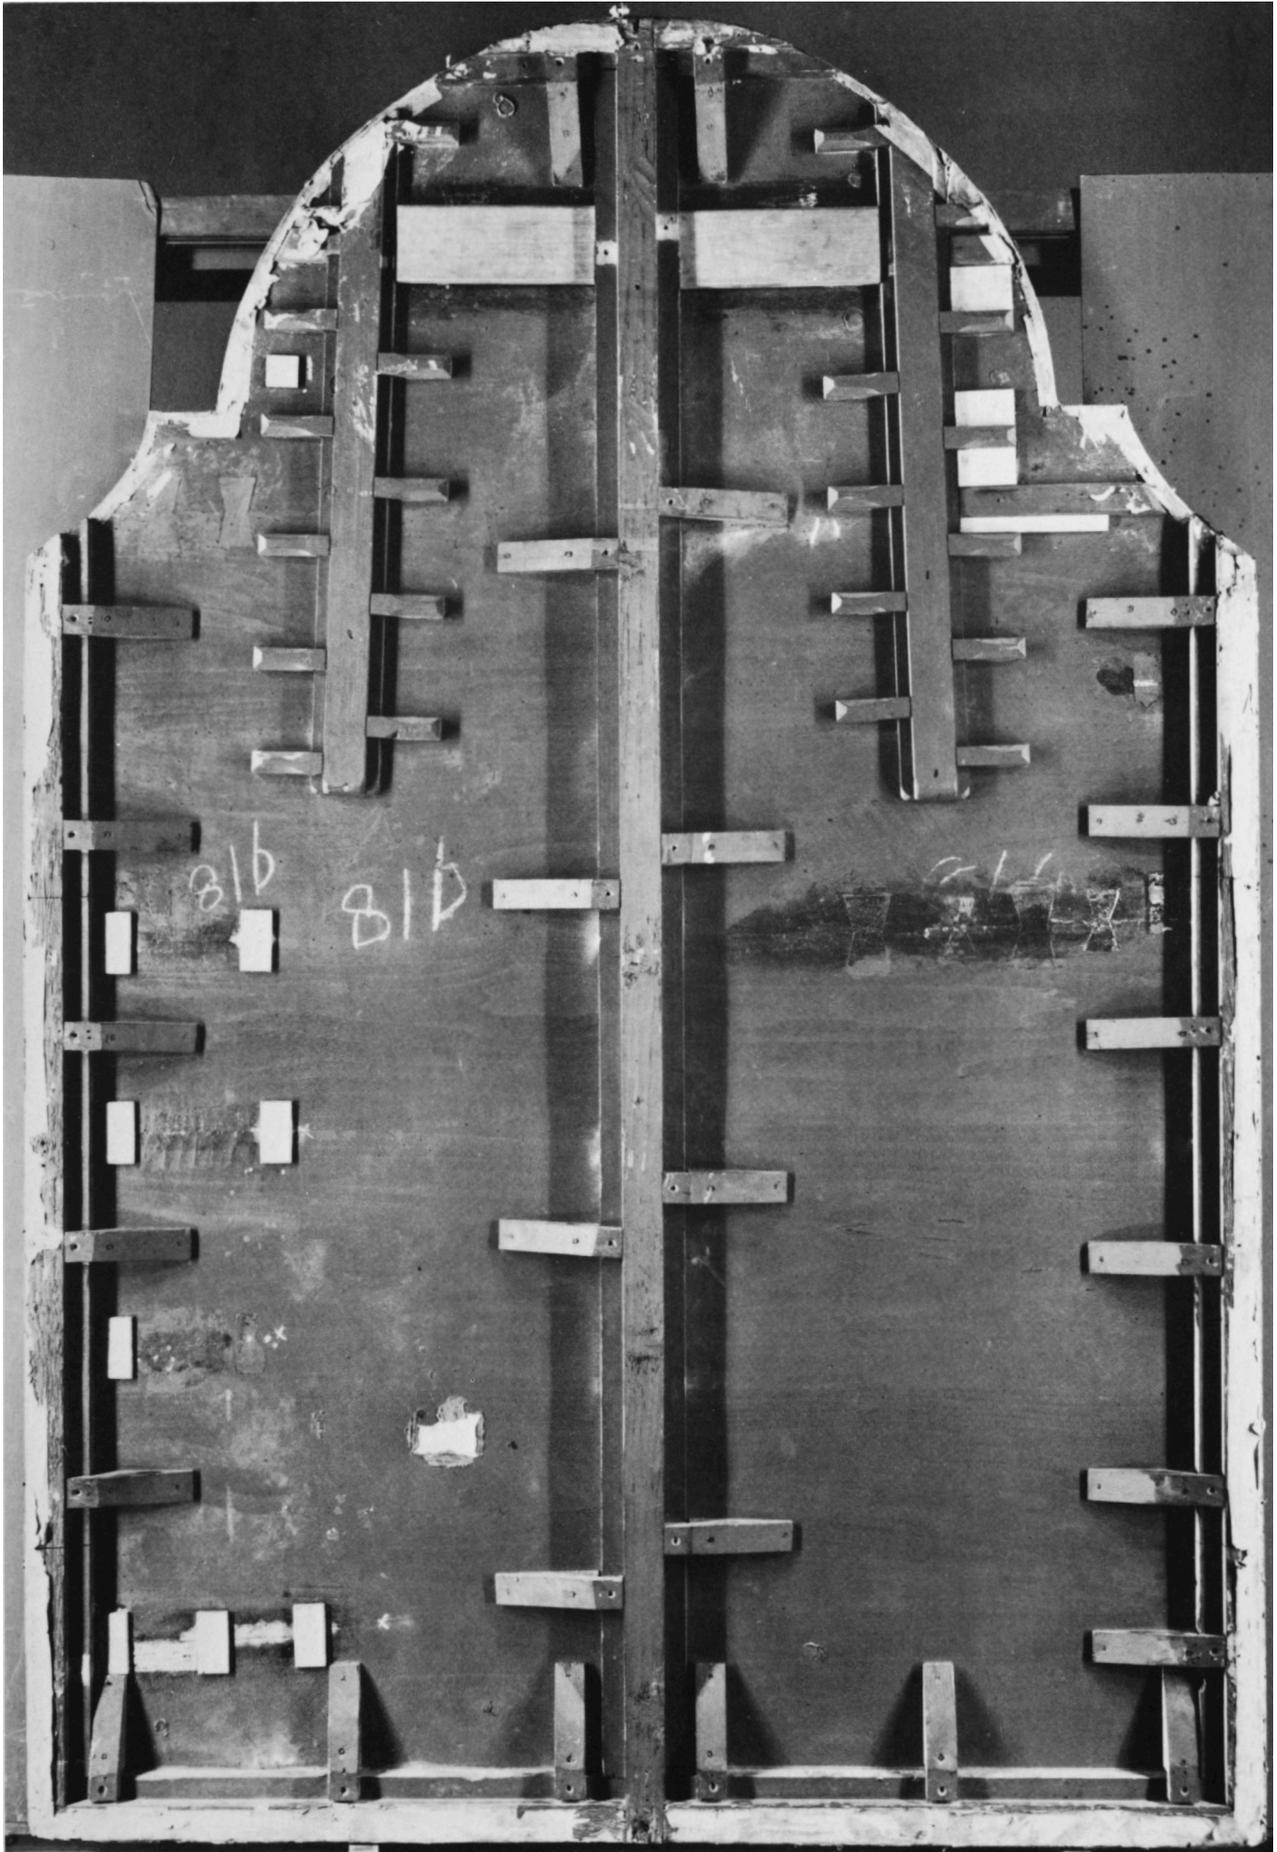
Figure 8 The back of the panel before treatment.

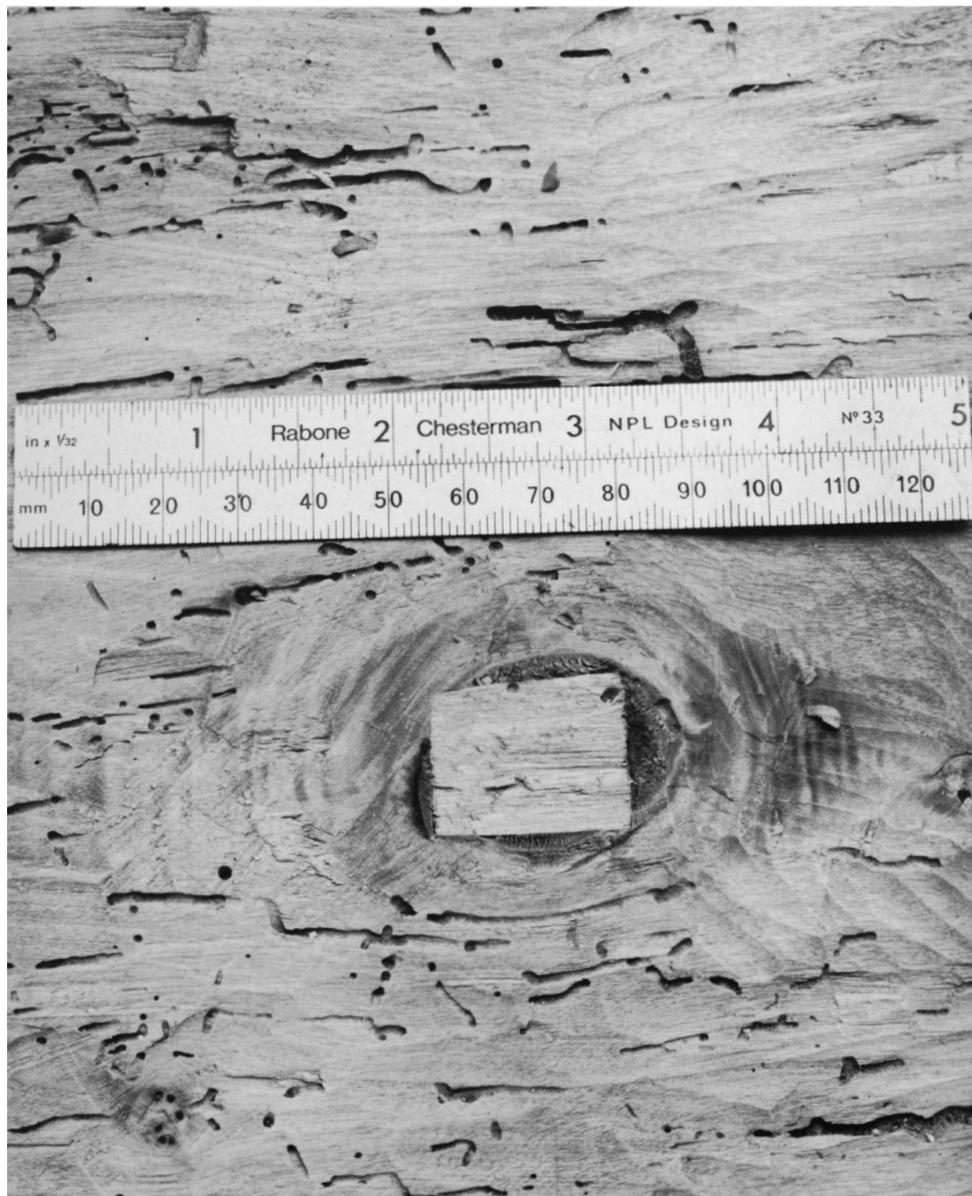
Fig.9 shows a detail of the back of the panel at this stage. The middle of a knot had been cut out from the front and replaced with a square plug by the panel maker; the disturbance in the grain of the wood near the knot can be seen. Fig.10 shows the bottom right corner of the back of the panel. The horizontal line just below the top of the illustration is the lowest of the six joints between the planks. The worm damage revealed by the reduction in the thickness of the panel is typical of that found everywhere. The worm channels vary in diameter from less than 1 mm to nearly 4 mm. More worm damage was found along some of the joints, particularly the top two; the protein in the glue (casein) used to join the planks is considered a delicacy by woodworm beetles. As layers of wood were removed from the back of the panel, more worm damage was found near the painted side than there had been near the unpainted back. The worm damage visible in Figs. 9 and 10 was not unusually severe and had not seriously affected the strength of the wood. There were very few exit holes in the front of the panel; it was later found that there were many semi-circular depressions in the back of the gesso which had been made by the insects. The battens which had been fixed to the back of the panel before its purchase by the National Gallery (Fig.8) were necessary because the joints had been loosened by the warping of the individual planks, and possibly by the picture's submersion, and not because each individual plank had been undermined by woodworm. Many poplar panels of the fourteenth- to sixteenth-centuries in the National Gallery Collection have been far more severely attacked by woodworm and dry-rot than Cima's altarpiece, and yet still provide an adequate support for the gesso and paint layers.

Figure 9
A detail of the wood after it had been reduced from c. 5 cm in thickness to c. 1 cm. The repair in the knot was made by the panel maker before the gesso was applied.

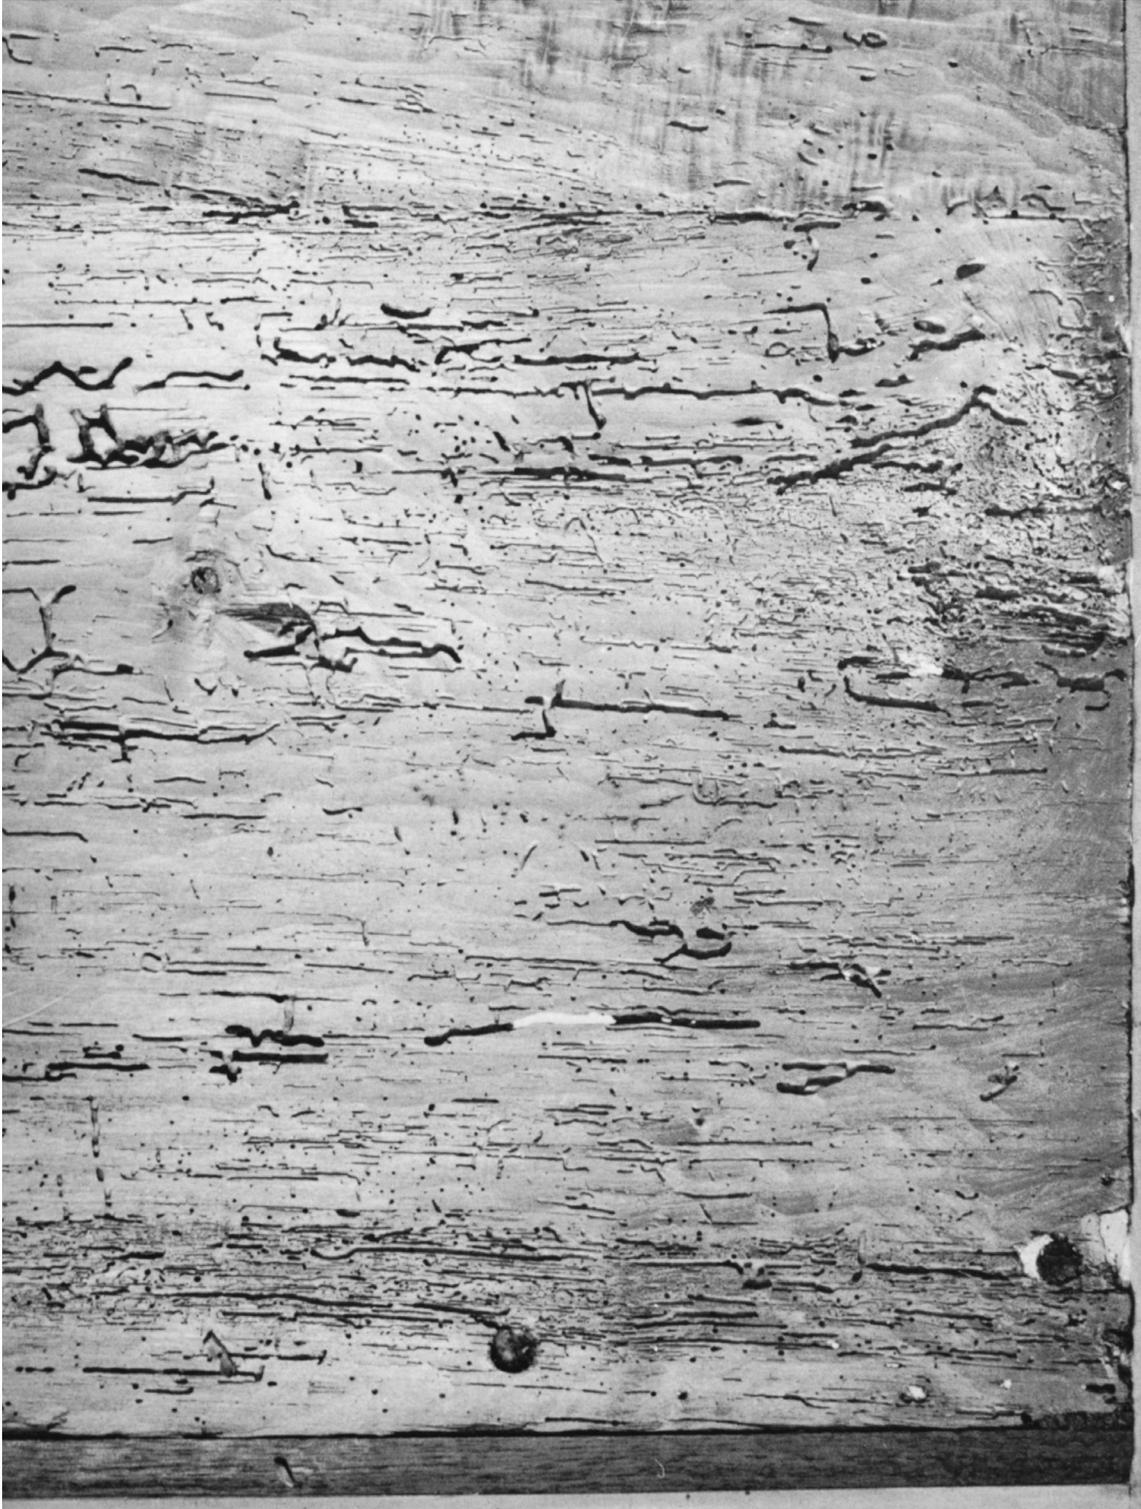
Figure 10 The bottom right corner of the back at the same stage as Fig. 9. The horizontal line near the top is the lowest of the six joints; the bottom plank is *c.* 44 cm high.

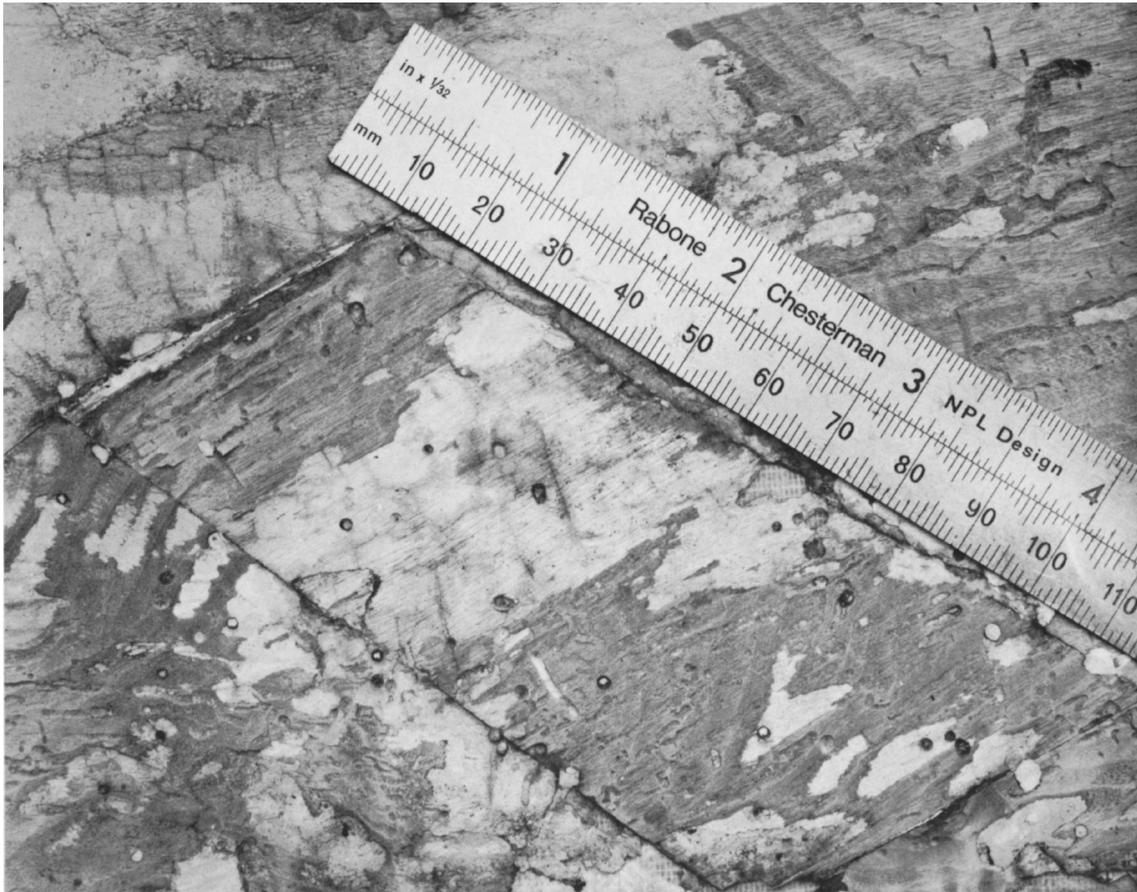
Figure 11 An original parallelogram shaped repair near the bottom of the picture during the removal of the last layer of wood. The wood and gesso were well attached here.

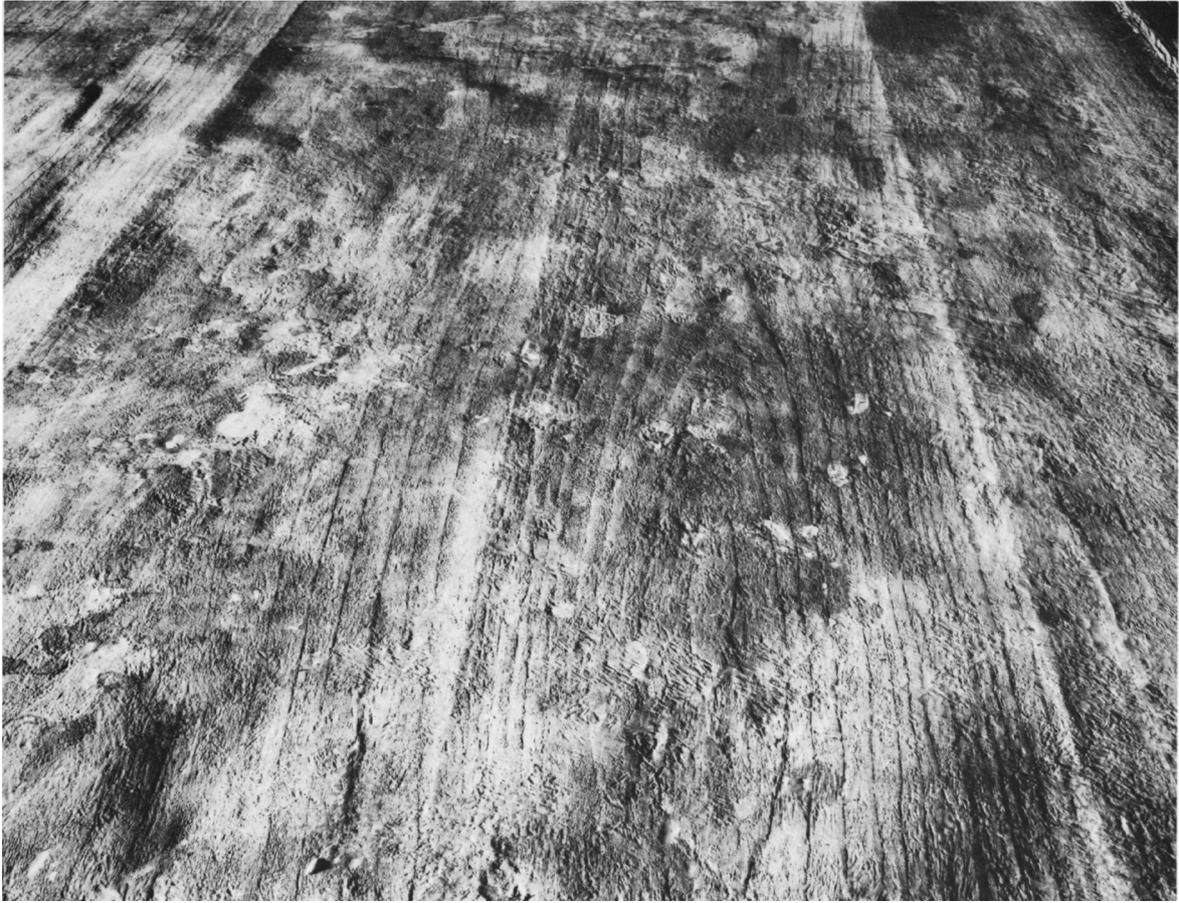
Figs.12–14 show the back of the gesso after the removal of all the wood. Fig.12, taken in raking light from the side of the panel, shows the reverse impression of the poplar grain; the panel was clearly rough enough to provide a good ‘tooth’ for the gesso. The two lines converging towards the top of the illustration are ridges in the gesso which mark the edges of planks; the gesso ‘remembers’ that each plank had a convex warp (as seen from in front) across its grain. Though it is difficult in raking light to distinguish between shadows and stains in the gesso, many of the dark patches are glue staining.

Figure 12 (Right, top) Raking light photograph of the middle of the picture, seen from the side. The two converging lines are the marks of one plank width.

2. The highest ridges (Fig.12) where the gesso had a reverse impression of the roughest poplar planks, were lightly scraped down with a scalpel, and some fillings of greater thickness than the gesso were reduced. Some small areas of cleavage in the gesso were treated; some perished or broken up gesso was removed and replaced with chalk and glue filling.

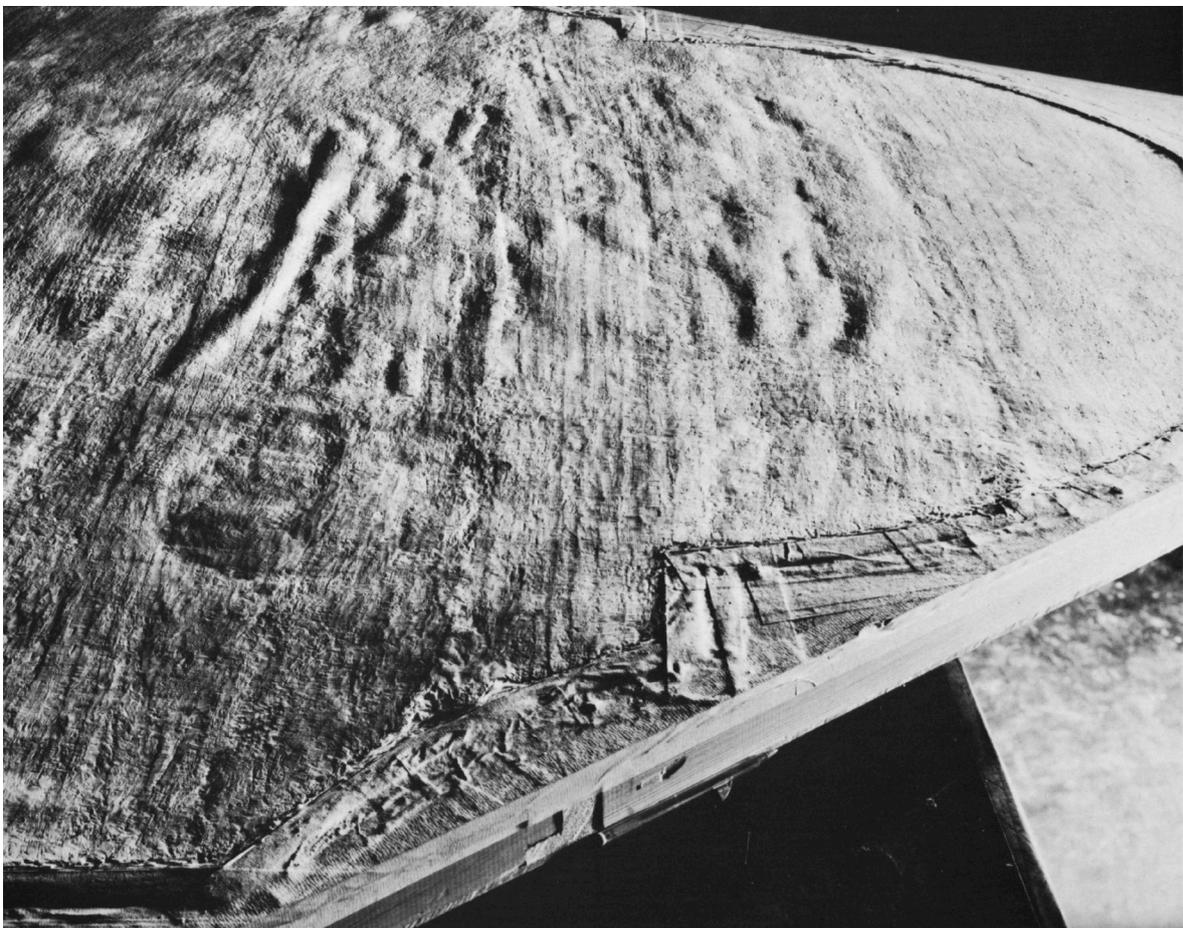
Fig.13, also taken in raking light, shows the arched top of the picture, where the removal of the final layer of wood had started. The panel and gesso had been carefully covered with Melinex and heavy rubber mats all through the transfer, but the gesso had absorbed some moisture from the atmosphere and swollen slightly. An air-conditioning malfunction, which produced RH of 100% for several hours one night, led to the pronounced swelling and buckling of the gesso which can still be seen in this photograph taken months later.

Figure 13 (Right, bottom) The top of the picture in raking light after the removal of the wood. The buckling in the gesso was reduced on the hot-table.

1. Fig.13 shows the severe buckling of the top of the picture due to the gesso having absorbed moisture from the atmosphere. Less pronounced buckling had affected some of the lower half of the picture as well. The facing layers had moved with the gesso, and were still secure. The picture was detached from the temporary support and slid face-down onto the Melinex covered hot-table, sealed with a membrane and heated to 40°C at a pressure of 15 mbar (1.5 kPa) for an hour. The buckling slowly reduced until the picture was almost flat and relaxed, and the same low pressure, which prevented any alteration of the surface texture, was maintained while the hot-table cooled.

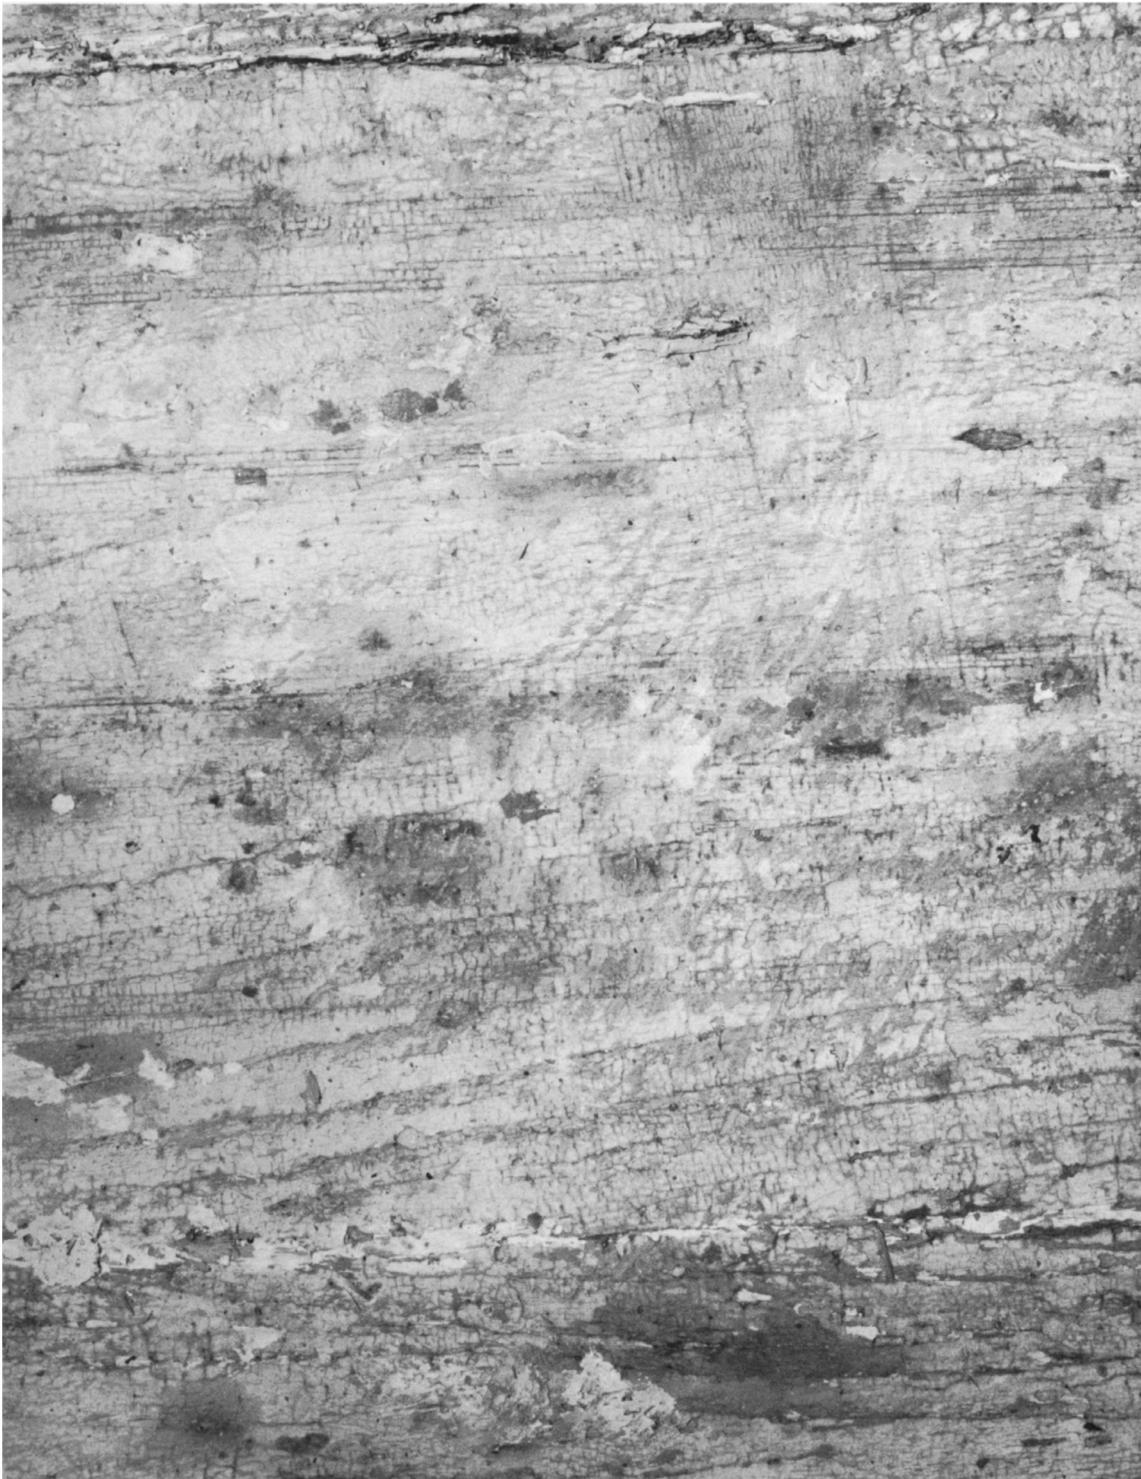
The facing was able to withstand the expansion of the gesso and remained securely stuck to the paint. Fig.14, taken in ordinary light, is of one plank’s width at the top of the picture; it shows some staining of the back of the gesso and also the incised lines which indicate the positions of the roof beams; the floor tiles and the arched windows in the grey wall were the only other part of the design to have been incised.

Figure 14 A detail of the gesso at the top in ordinary light. The lines incised in the gesso to indicate the roof beams can be seen, as can some staining of the gesso.

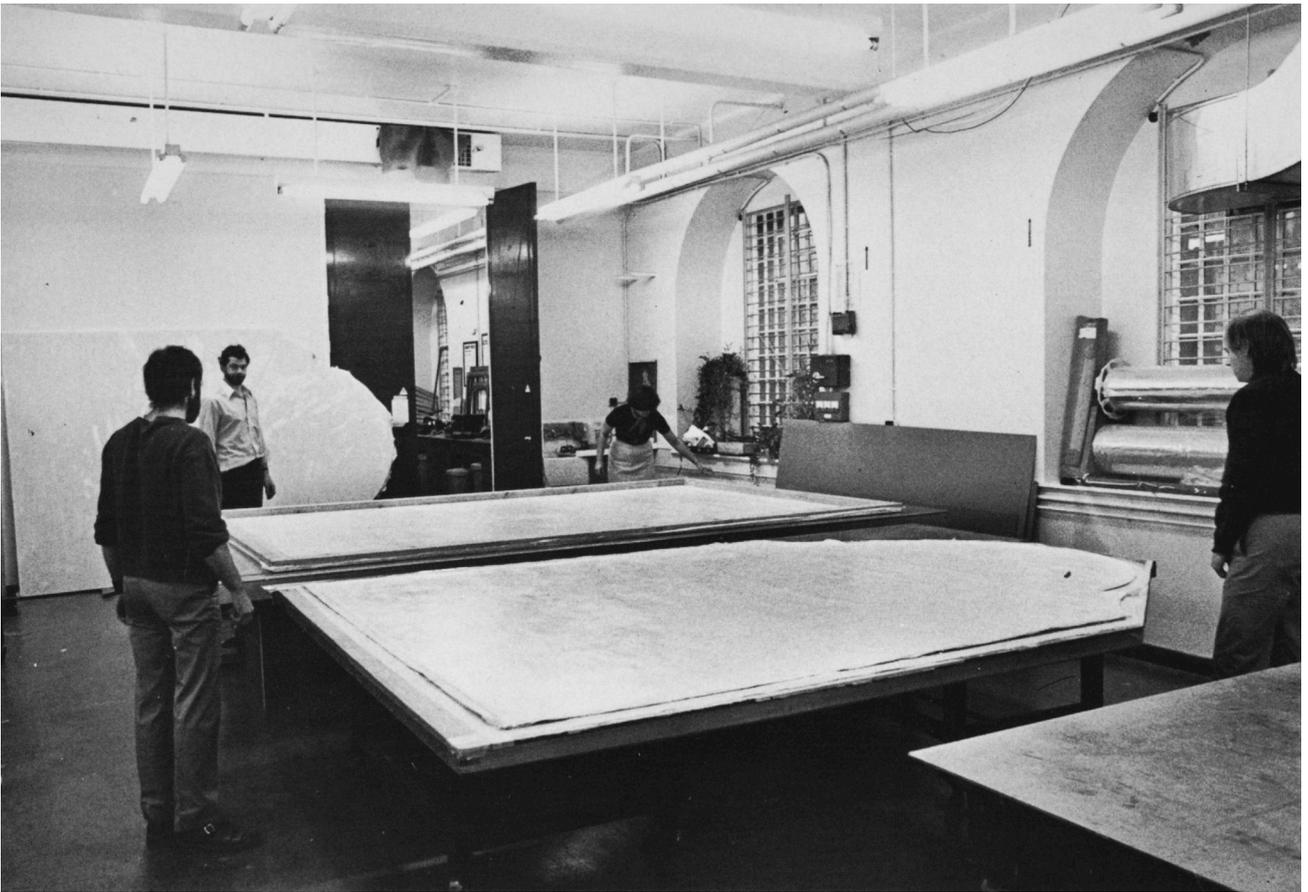
Figure 15 The back of the picture after it has been reinforced with acrylic primer and the texture filled to make it smooth. Beyond is the hot-table with the linen interleaf, and beyond that the aluminium honeycomb and fibreglass panel.

7. The aluminium honeycomb and fibreglass panel (Fig.15) was supplied by Fine Art Stretchers and Services Inc. [4]. The core was of 34 mm aluminium honeycomb, with one vertical and three horizontal box-section aluminium bars to ensure rigidity, faced with resin-impregnated fibreglass attached with epoxy. The fibreglass was butt-jointed over the aluminium bars. To eliminate any possibility of the construction of the panel or the pattern of the honeycomb core showing on the face of the picture, a sheet of 'Fibr Plate' [5] was glued with epoxy to each side of the panel, and fine fibreglass fabric over the front. The fibreglass fabric was filled with a chalk/vinyl emulsion filler and sanded. Three coats of Beva 371, diluted with 50% by volume white spirit, were brushed onto the front of the panel. The linen/picture layer was removed from the loom and positioned over the panel. The hot-table was used to attach the linen to the panel; the table was set at 78°C to compensate for the thickness of the panel, with the pressure again at 20 mbar (2 kPa). After the table had cooled, the panel was removed and the linen (which had been cut c.30–40 cm larger than the picture) was tacked to the sides and back of the panel with one coat of Beva 371.
