National Gallery Technical Bulletin

Volume 9, 1985

The Transfer of Cima's 'The Incredulity of S. Thomas'

Martin Wyld and Jill Dunkerton

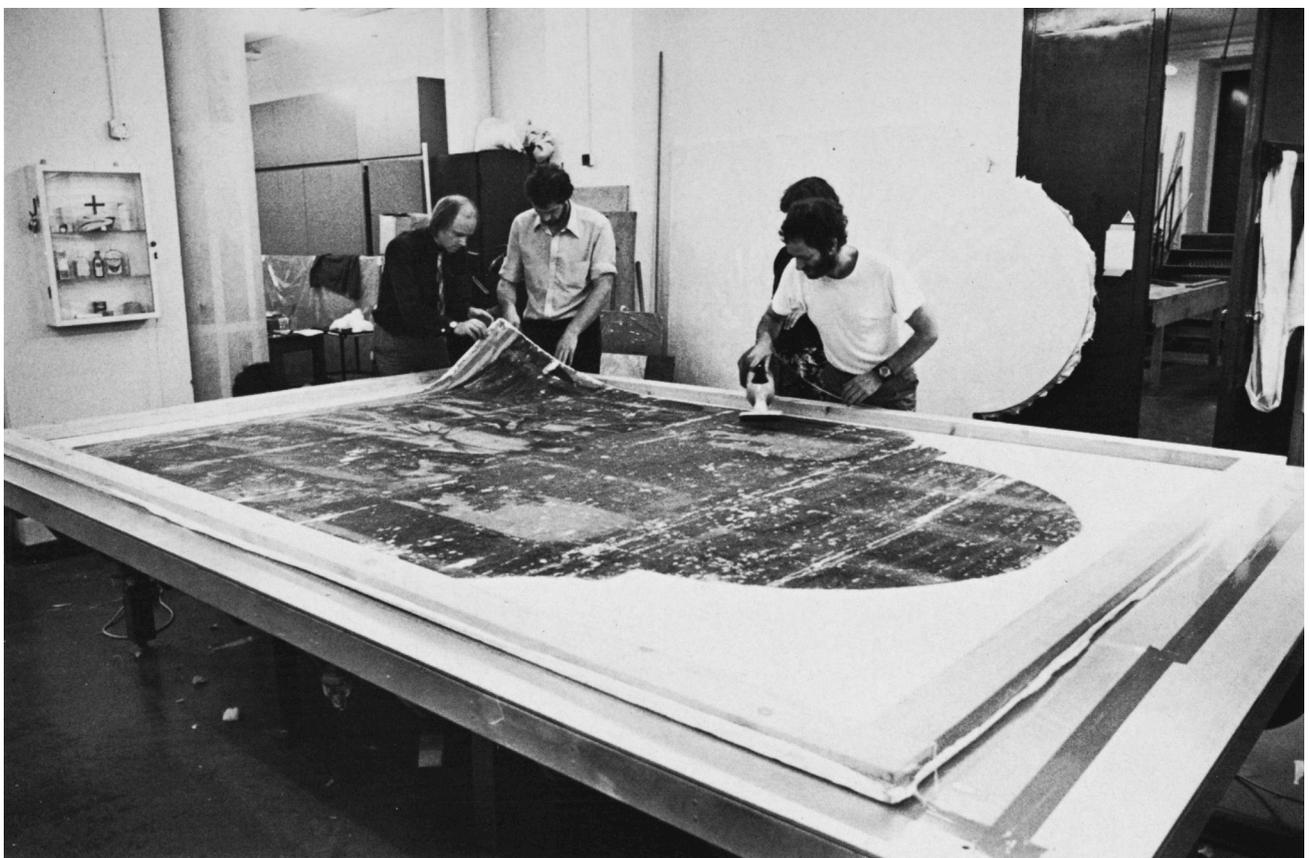
Figure 16 The picture being positioned on the linen interleaf.

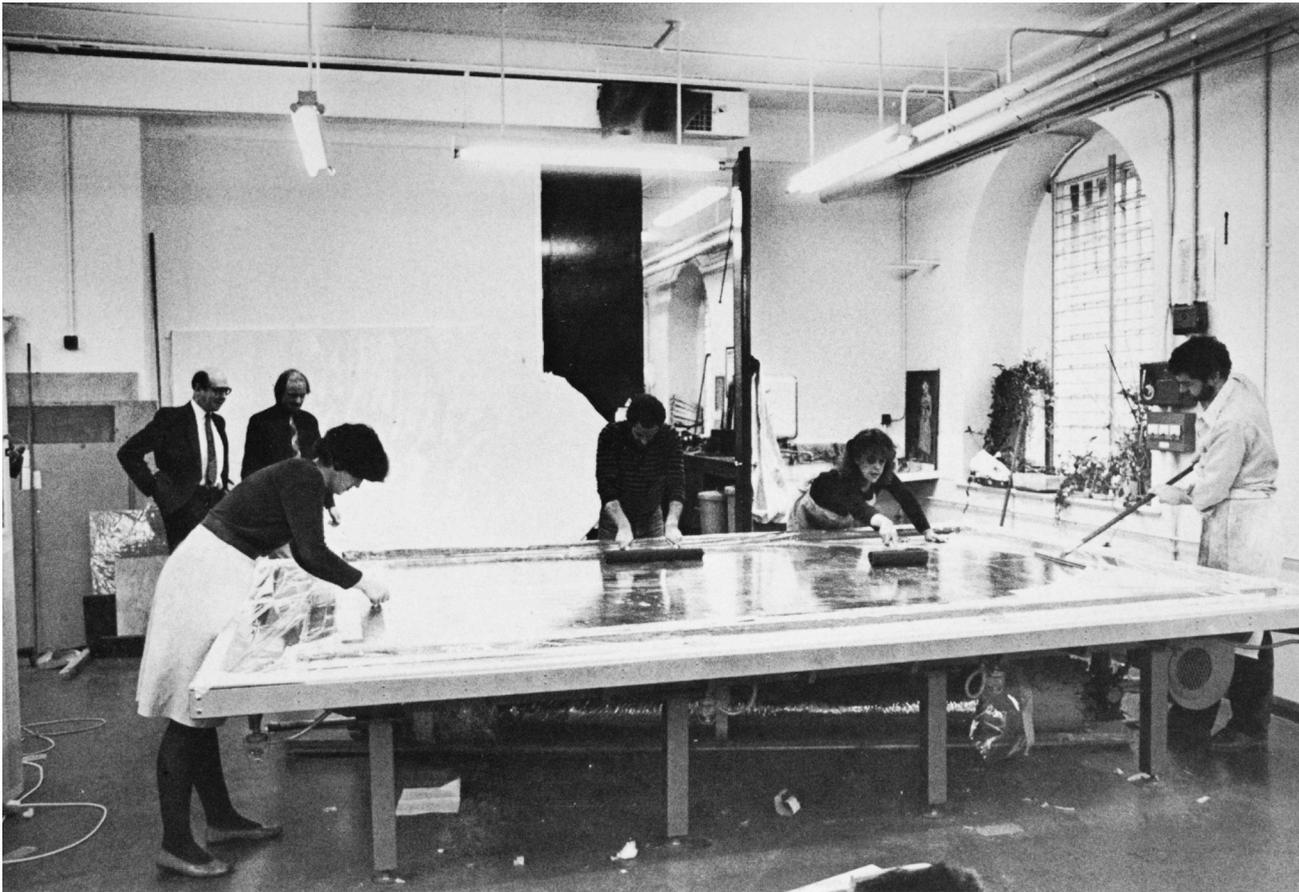
Figure 17
The picture being attached to the linen interleaf on the hot-table.

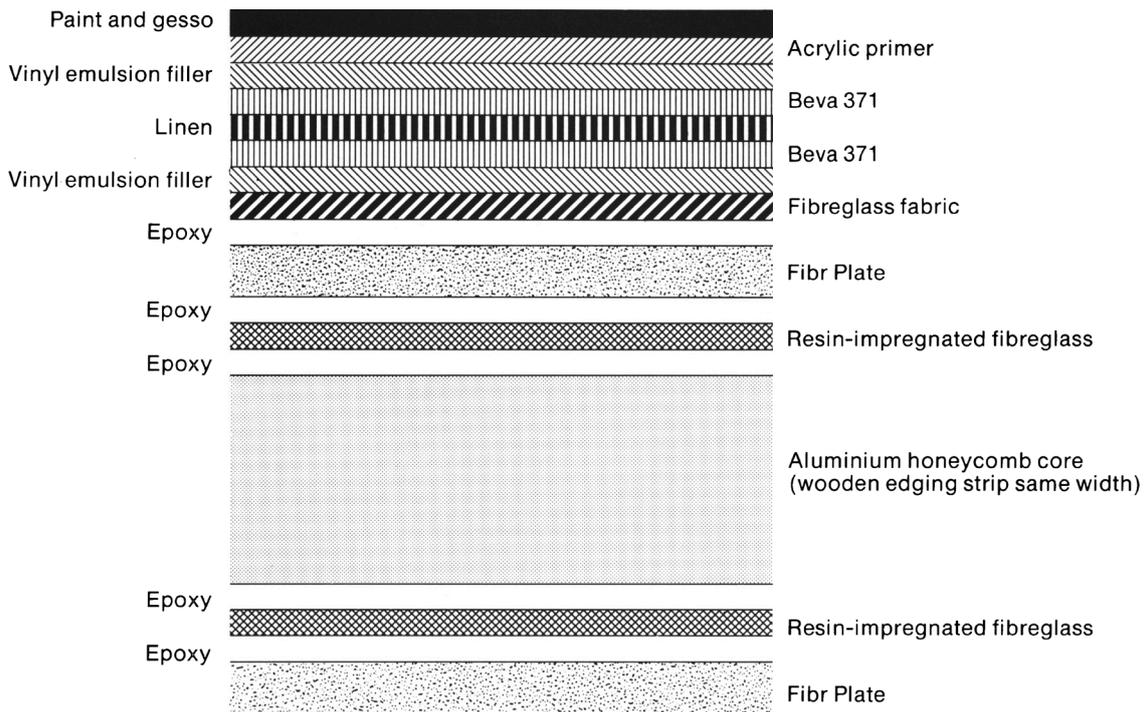
Figure 18 Diagram of the new support and the layers reinforcing the gesso.

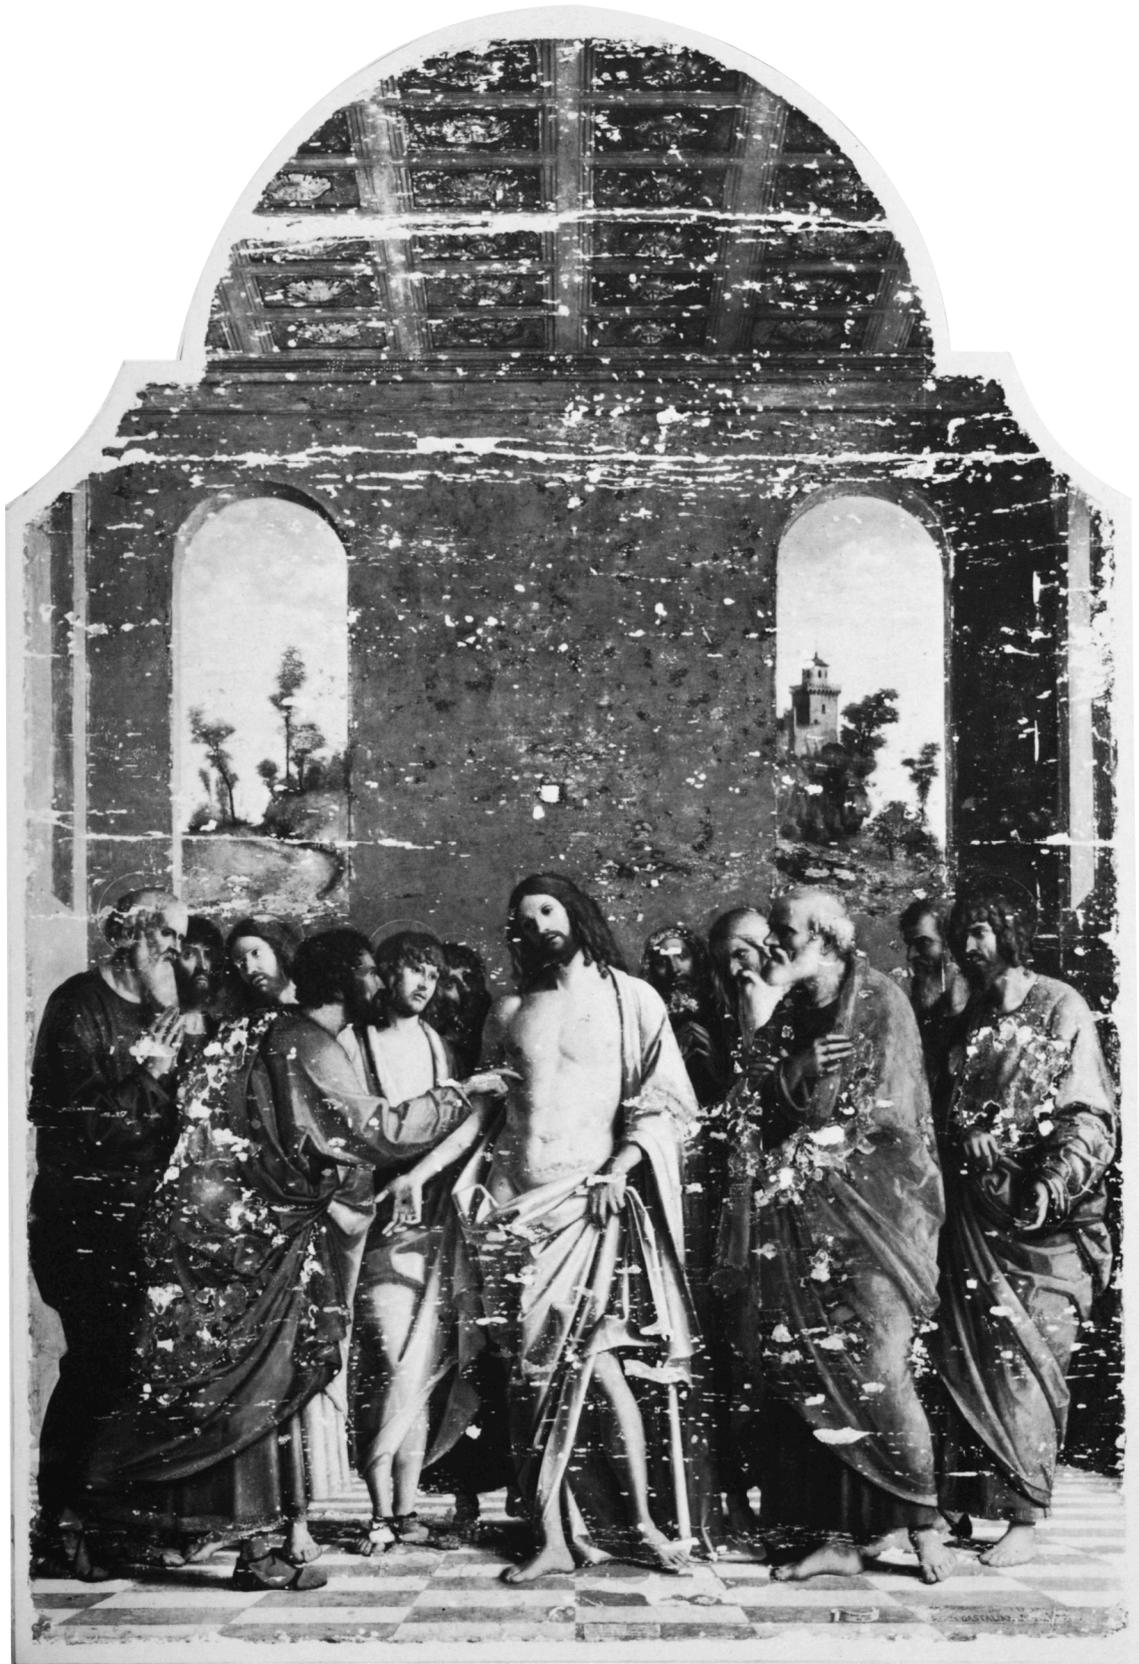
Figure 19 The picture after cleaning and transfer.
