# National Gallery Technical Bulletin

Volume 2, 1978

# The Conservation Department of the National Gallery

David Bomford

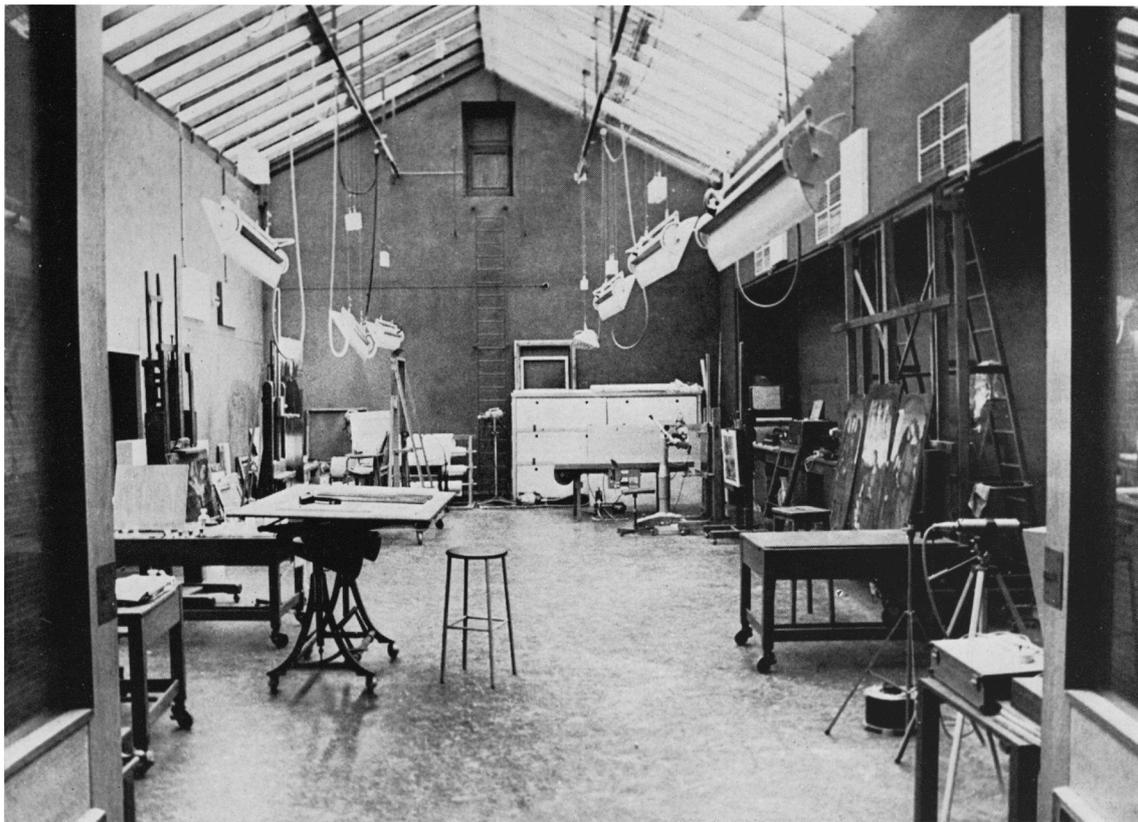
**Figure 1** The north Conservation Studio. The south-facing slope of the roof (right) has an internal system of venetian blinds. Banks of fluorescent lights are suspended, with counterweights, from tracks running the length of the studio. The large hydraulic easel (right) is capable of raising 750kg. The small vacuum hot-table (3m×1.2m) can be seen beyond the microscope at the far end.

The south-facing slope of each roof is entirely covered with an internal system of venetian blinds, operated from floor level. This serves two functions.

Firstly, it is possible by closing them to obtain pure north light, a steady, cool illumination, unaffected by the fluctuations of sunshine; in fact, for the examination of pictures the strength of the light source is rather more important than its purity, and restorers, like most human beings, prefer to sit on the sunny side of the room.

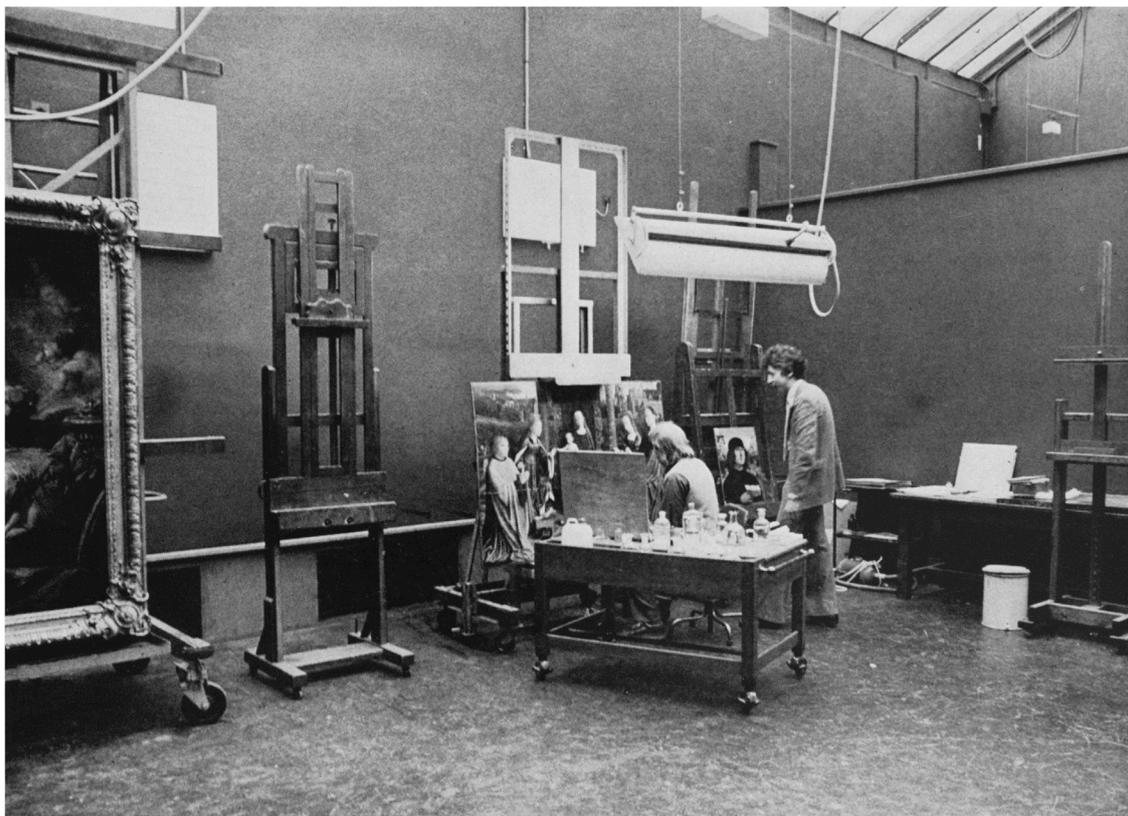
**Figure 2** Part of the South Conservation Studio. Behind the partition at the right is the Chief Restorer's studio. The wheeled trolley, for use beside the easel, holds the restorer's palette box, instruments, solvents, varnishes etc. When not in use, bottles are stored in a trough, visible on the near side.

Of the main studios, the southern one is divided by a partition of about half roof-height, behind which the Chief Restorer may work on projects of particular difficulty or confidentiality. All walls are painted in dark matt colours to avoid unnecessary reflections, especially disturbing during retouching.

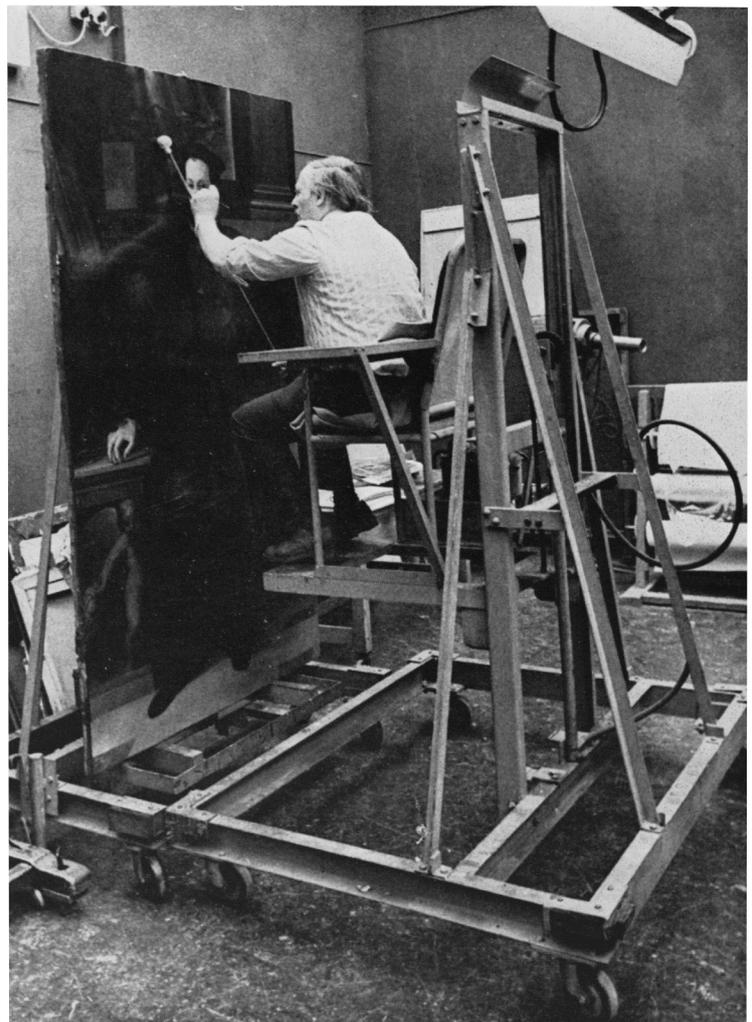
**Figure 3** Hydraulic easel and chair. This small hydraulic easel is designed to carry 150kg. The chair will rise to a seat height of 2.1m and has surfaces on either hand for solvents, paints and instruments.

The restorers work at easels both of the traditional studio type (for smaller paintings) and of a hydraulic type designed by the (then) Ministry of Works. The hydraulic easels are manually operated and incorporate gear mechanisms to enable exceptionally heavy weights to be raised easily by a single person: the largest of these easels will comfortably accommodate the most massive pictures in the Collection. Of a

similar design are hydraulic chairs which allow restorers to work in comfort (a consideration which is by no means unimportant) on the tallest of pictures. The Department has just taken delivery of two-dimensional tracking easels which will allow movement in a horizontal as well as a vertical plane: these are invaluable when scanning a painting microscopically or photographically.

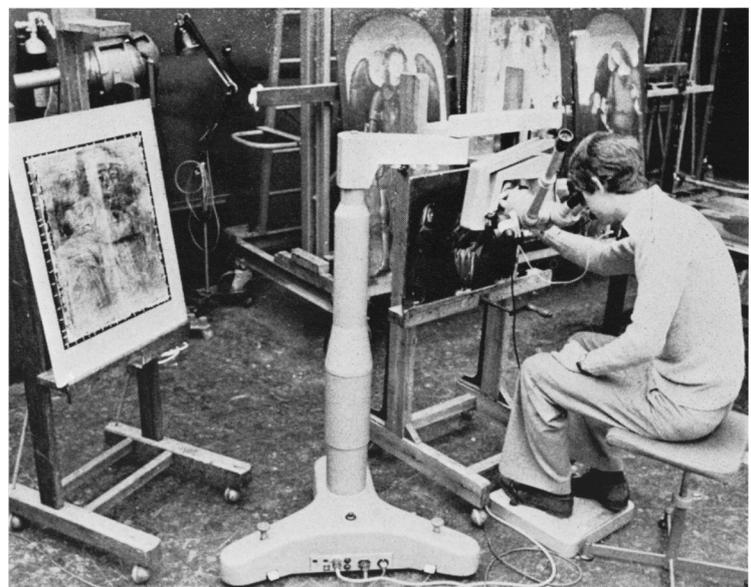
**Figure 4** The Zeiss 'Operation Microscope'. The foot-operated switch-panel leaves the operator's hands free for work on the picture itself. The microscope can be used with the picture in an upright or a horizontal position. To the left of the normal eyepieces is a monocular observation tube for a second observer.

The surface examination of paintings is carried out in the conservation studios using a variety of aids. The restorer relies most simply on direct visual inspection and low-power magnification provided by a 2× binocular magnifier or a 6× pocket lens. For greater magnification the Department has a motorized Zeiss 'Operation Microscope' with stereoscopic zoom optics, originally designed for use in microsurgery. Controls are mounted on a foot-operated switch panel, leaving both hands free for manipulative procedures on the picture itself: footswitches are provided for height adjustment, fine focus up and down, zoom magnification in and out.

By variation of eyepiece and objective lenses a range of continuous magnification from 2.5 to 53× can be achieved, with a depth of field quite able to cope with the most extreme variations in surface configuration. Two illuminators are positioned one on each side of the objective; one is for homogenous light, the other is focusable and they may be switched independently to give raking light. Between the objective and the eyepieces a beam splitter is incorporated to allow a monocular observation tube (for a second observer) and a 35mm camera to be mounted.

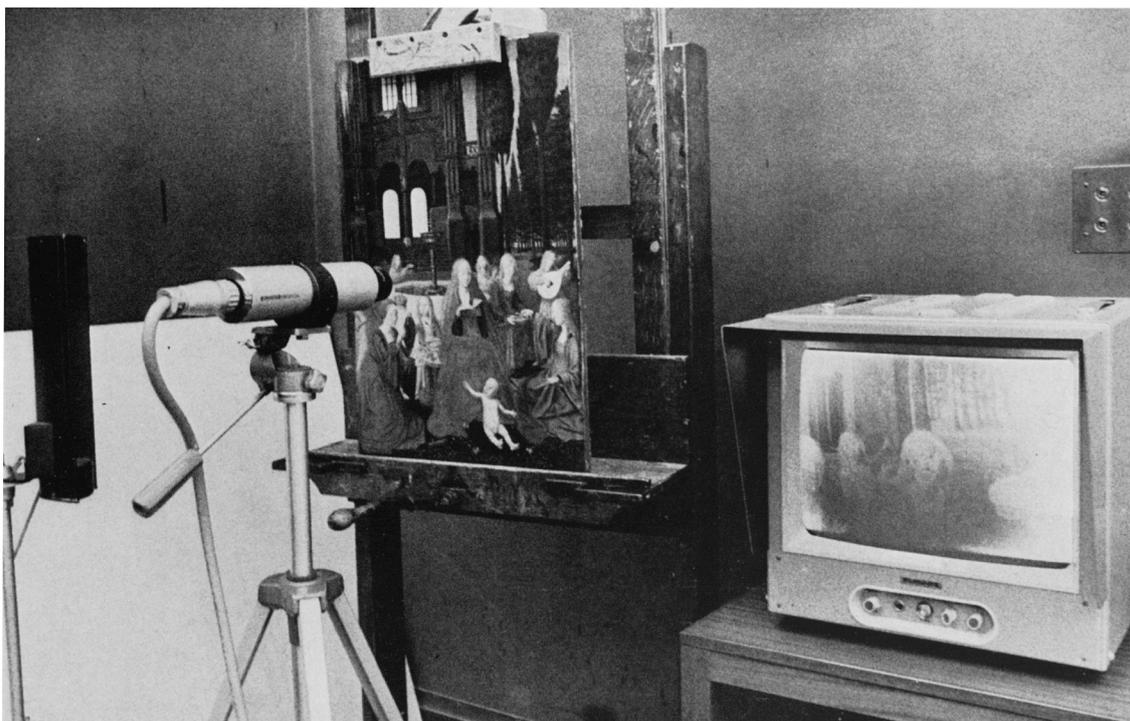
**Figure 5** Infrared vidicon television system: a simplified version of a system pioneered by J. R. J. van Asperen de Boer. The painting is illuminated by a quartz lamp (in a black reflector, left) controlled by a variable resistor. The camera, containing a PbS detector, is connected through an amplifying system to the monitor (right).

Until recently, restorers, historians and museum scientists have desired a similar way of making an infrared image instantly visible—without having to wait for photographs to be developed and printed. This is now possible through a system (pioneered by J. R. J. van Asperen de Boer in Amsterdam) incorporating an infrared vidicon connected to a closed-circuit television monitor. In conjunction with the Scientific Department, the Conservation Department runs one of these. The method (*infrared reflectography*) also has advantages over conventional infrared photography in that it is sensitive to longer wavelengths in the infrared region of the spectrum: this allows penetration of pigments (principally greens) which otherwise appear black on an infrared photograph.

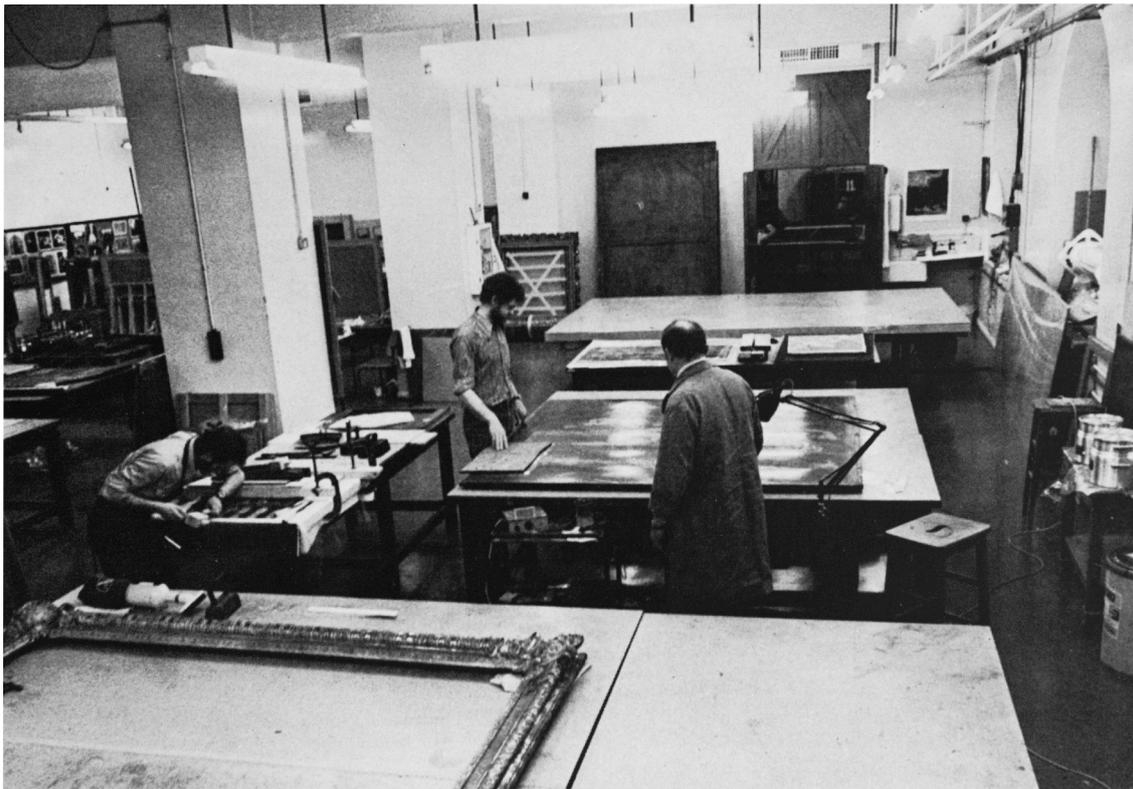
**Figure 6** The main Conservation Workshop looking south. The work-tables may be combined to form a surface of almost any size: a single one, with a panel undergoing treatment clamped to it, can be seen centre left. The small trolley, centre foreground, holds electrically heated spatulas with their control box. The photographs on the wall (extreme far left) are part of the permanent display of conservation materials and methods. Beyond the large hot-table (far right), through the doors, are the carpentry workshop and the 'hospital'.

The workshops consist of four principal rooms and two storage areas. The two largest rooms—the main workshop and the carpentry shop—have a combined area of about 320 square metres; in addition, there is a varnishing room and the 'hospital'.

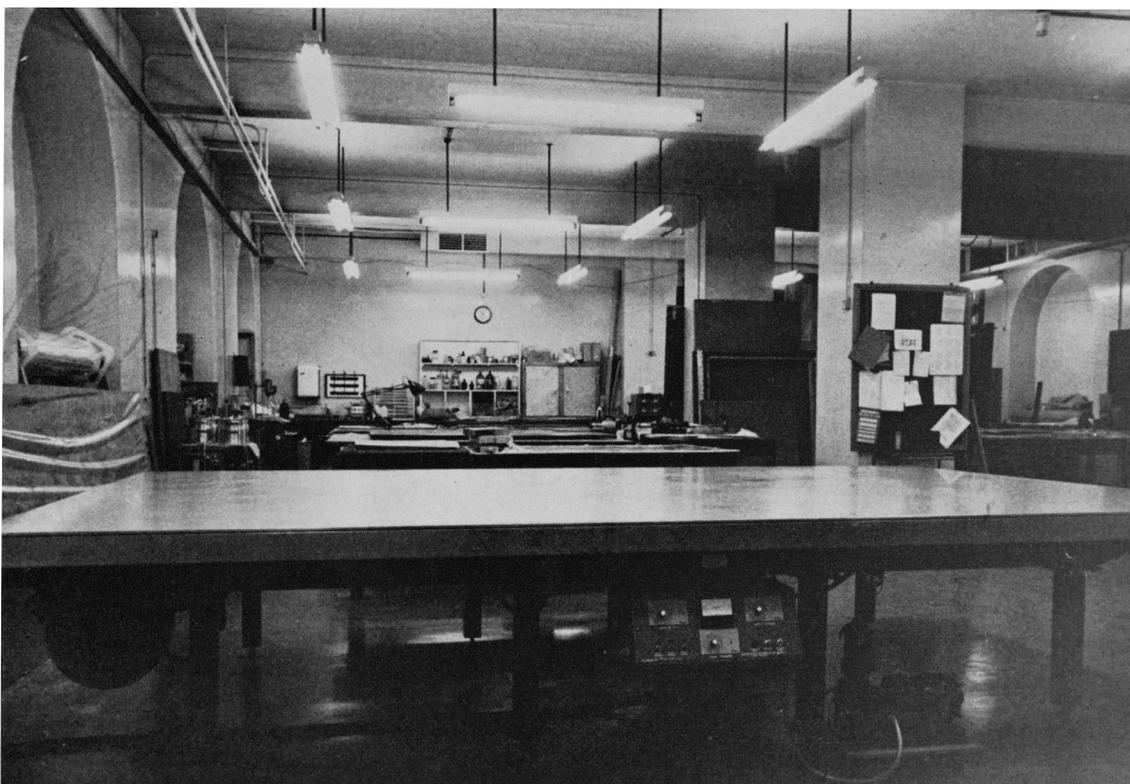
**Figure 7** The main Conservation Workshop looking north. The large vacuum hot-table (foreground) measures 4m×2.5m. The control panel incorporates separate controls for main and edge heaters and a safety cut-out overriding both. When not in use, the hot-table is covered and provides another work surface. The varnishing room and the lift serving the North Conservation Studio are beyond the doors just visible at the far right.

The main workshop is specifically for the conservation of supports (the structural layers of pictures) which, with a few exceptions, can be characterized as either canvas or wood panel. The most striking item of equipment in the room is the massive 4 × 2.5m vacuum hot-table, for the lining of canvas pictures. Like the small one in the Conservation Studio, it is designed and built by Willard Developments. Driven by a 415 volt supply, it incorporates two sets of heating elements—the main system and separate edge heaters which lie under the perimeter of the table. The purpose of the extra edge heater is to compensate for heat losses from the exposed sides of the table. It is switched on 10–20 minutes before the main heaters

to minimize losses during the heating period; this initial warming-up time is dependent on the ambient temperature of the room. The main heaters may be switched to 'boost' which speeds up the heating process considerably and increases the main element loading from 12½ kW to 16½ kW.

There are separate controllers for the main heaters and the edge heater which cycle the elements off and on at the temperature set on the dial. Overriding both is a safety control normally set a few degrees above the other two; if that temperature is reached all elements are cut off and will only come on again if a reset button is pressed. Cooling fans and a vacuum pump are incorporated in the normal way. The vacuum ports, set at intervals around the outside of the table, have sealing screws removable by an Allen key: this enables any part of the table to be used without having to cover the whole surface with a membrane. The hot-table is at the same height as the work-tables already described—allowing canvases under treatment to be slid from one to the other.
