Rubens' 'The Watering Place'

Christopher Brown, Anthony Reeve and Martin Wyld

The treatment of the picture Anthony Reeve

Figure 2
Rubens, *The Watering Place* (No.4815), before treatment.

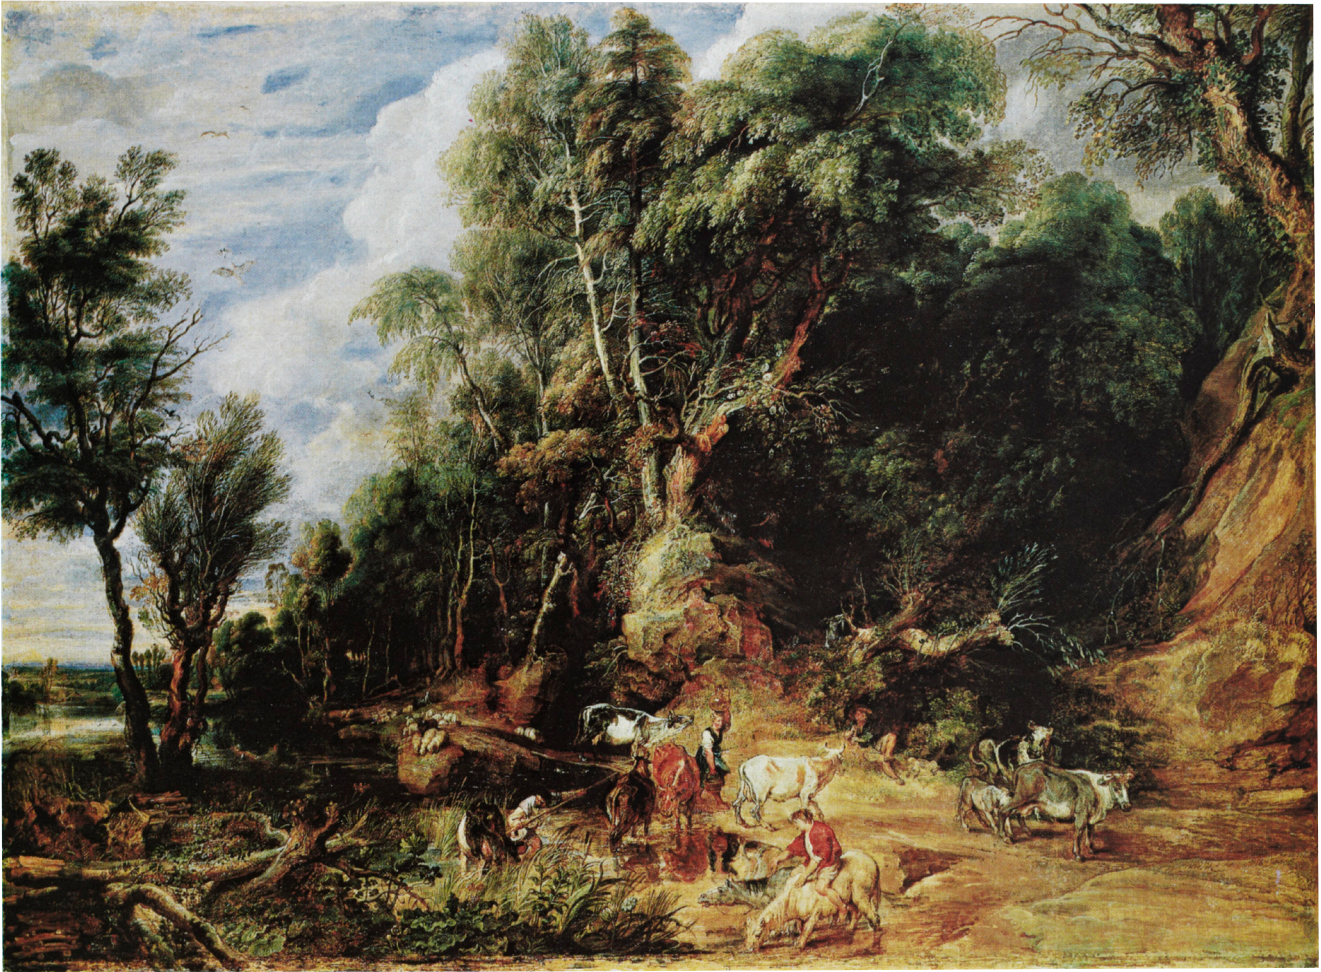
Plate 3 Rubens, *The Watering Place* (No.4815). After cleaning and restoration.

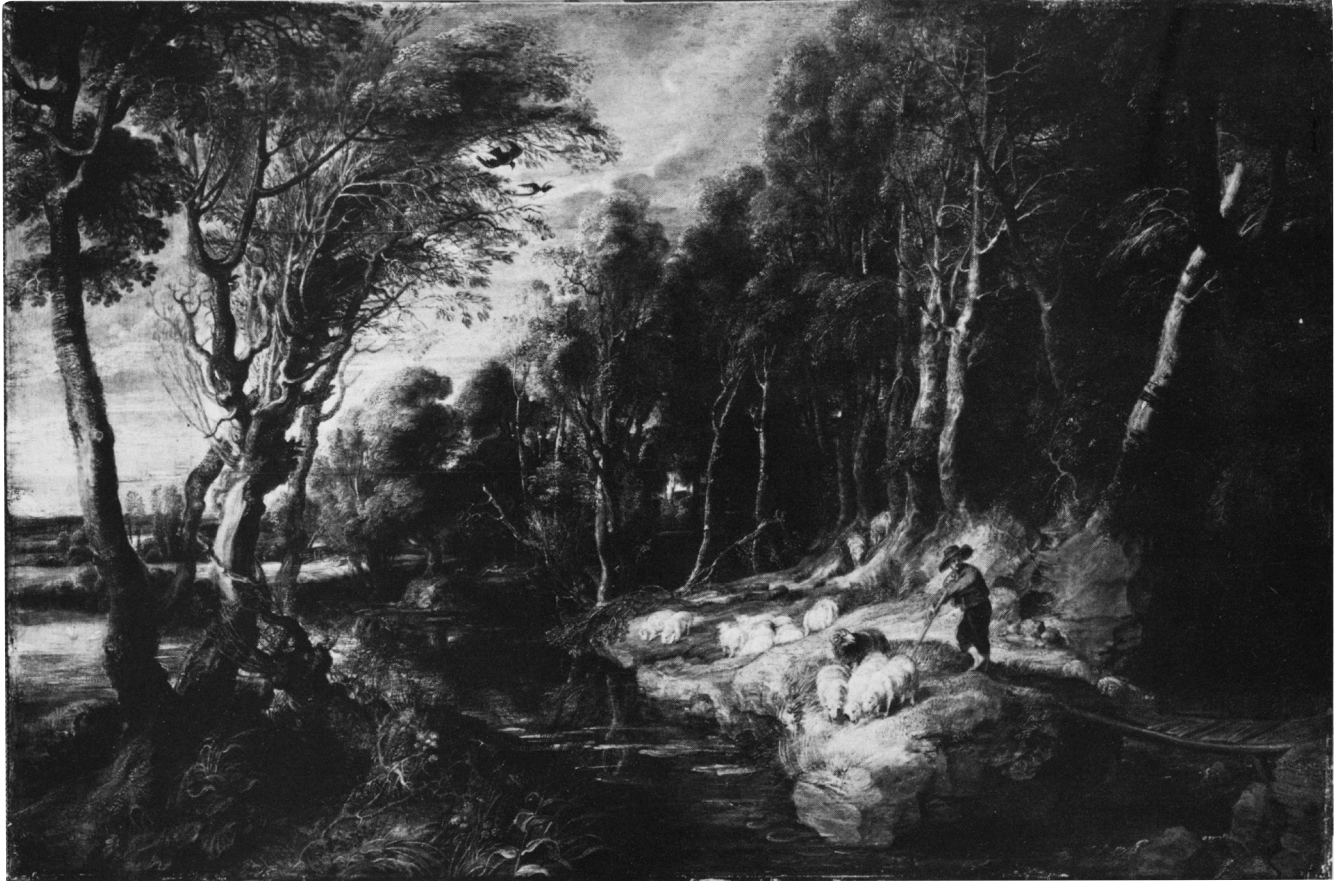
Figure 10 (Above) Rubens, *A Shepherd with his Flock in a Woody Landscape* (No. 2924), (0.639/0.644 × 0.943 m). Painted before *The Watering Place*, the first stage of which is a reduced repetition of No. 2924.

the first stage of expansion when planks 2,3,4 and 5 were added. The landscape on plank 1 is essentially a smaller version of No.2924 (Fig.10), which was itself painted in two main stages, with many alterations in the landscape. The panel of No.2924 which has a simpler construction (Fig.11) is being treated at present, and its paint surface has also proved to be in exceptionally good condition.

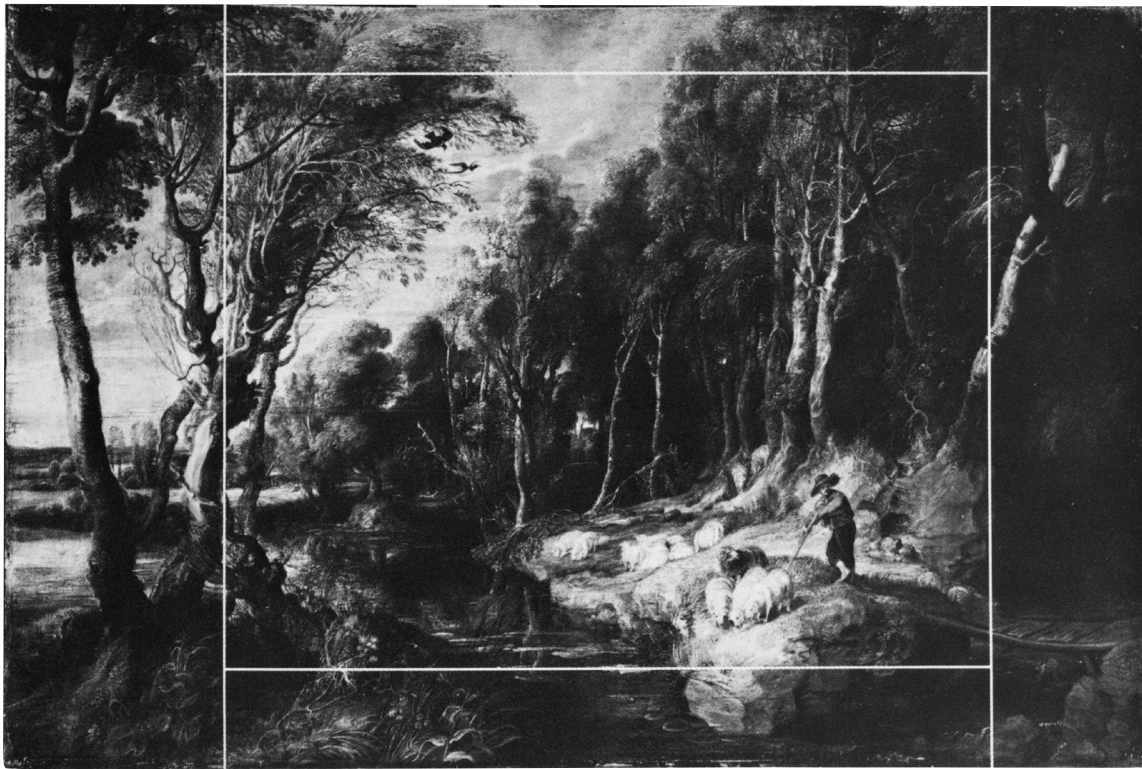
Figure 11 Rubens, *A Shepherd with his Flock in a Woody Landscape* (No. 2924). Diagram of panel construction. The first stage of the painting was confined to the single central panel, as with *The Watering Place*. Additions were made to all four sides for the second stage. Unlike the additions to *The Watering Place*, the planks at either end have a vertical grain, at right-angles to the first plank.

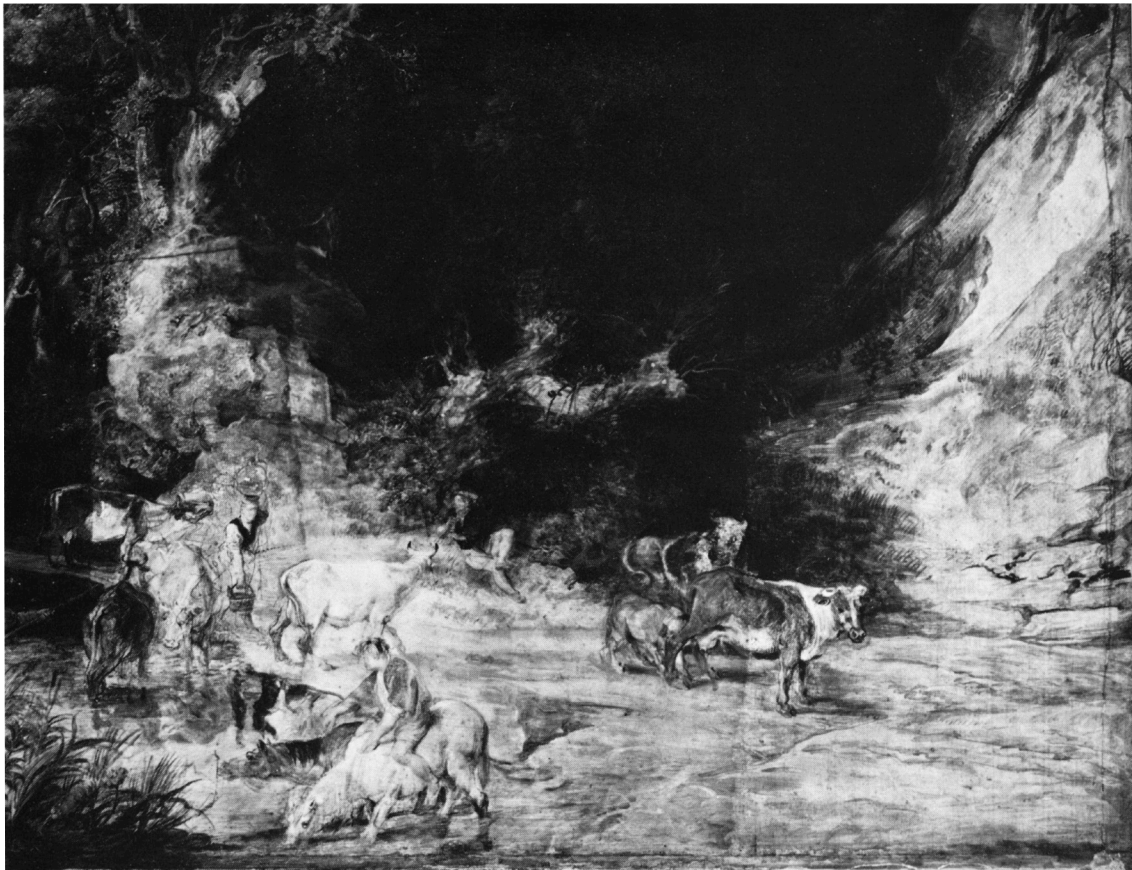
Figure 17 Infra-red detail of the bottom right corner. The joins between planks 4 and 7, and between 7 and 10, are visible.

The very good state of preservation of the paint surface can be seen in Fig.8. The infra-red photographs (Figs.16 and 17), show the differing thickness of the paint and ground between the different planks, and the comparative thinness of the paint on plank 10, the last to be added. Plank 2, the vertical plank at the left edge, is also more thinly painted than plank 1, the first support used. The position of the sun in the composition was moved to the left, presumably after

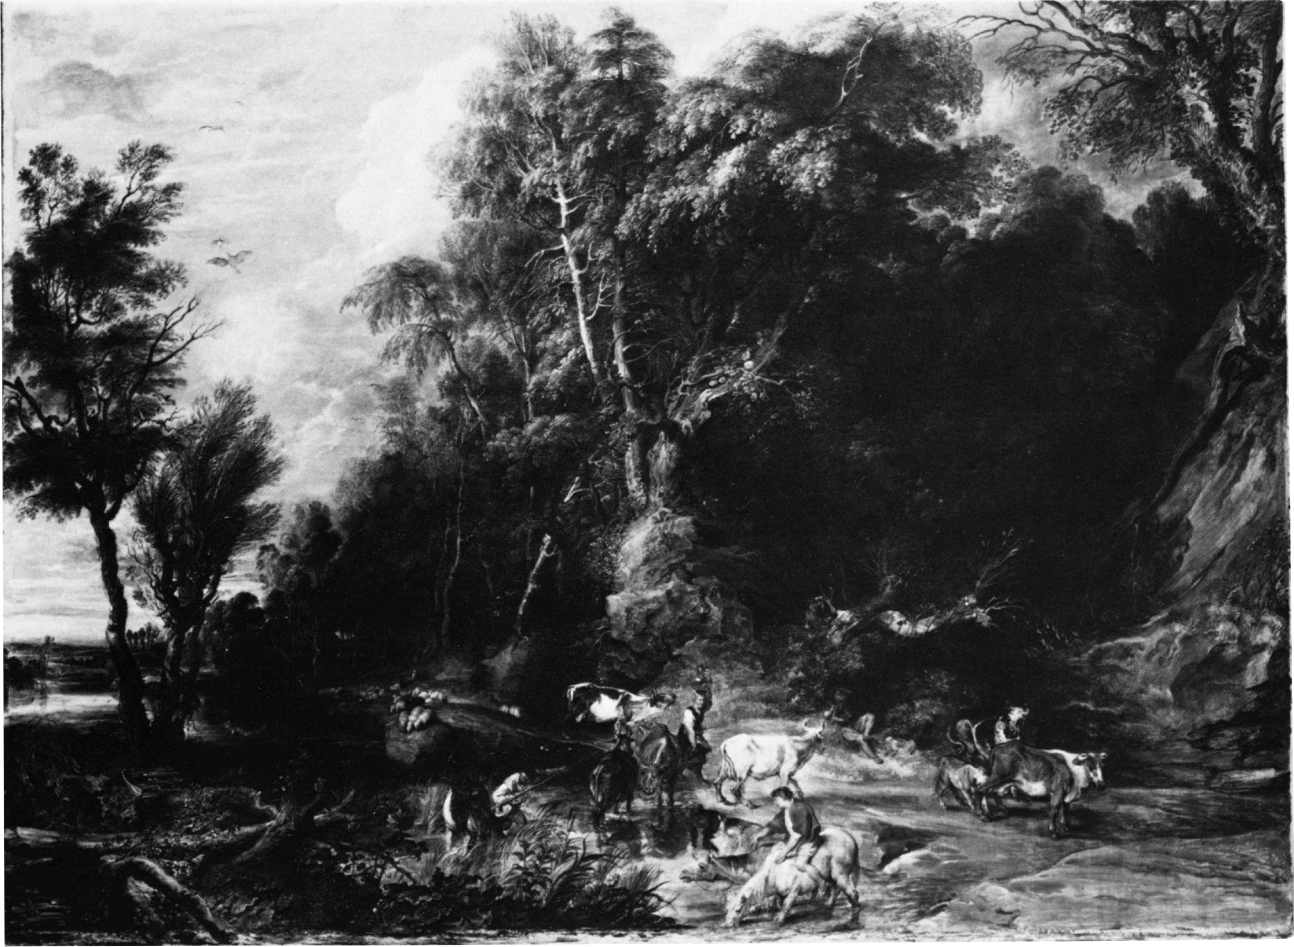
Figure 18
The whole after cleaning, panel-work and restoration (see also Plate 3, p.26).

The glueing of the splits occupied several weeks, the majority of the time being spent in removing the old glue and in preparing the clamping systems so that pressure could be applied both from above, below and from the side. The central bulge in plank 7 was considerably flattened and stabilized by the treatment of the splits in it. All the panel-work was done in the Conservation Workshop, an air-conditioned room on the ground floor of the National Gallery, and hence not subject to solar heat gain. The panel was kept covered, and variations in temperature and RH were small (temperature: 67–70°F, RH: 52–57%), but the stresses inherent in a panel of such complex construction were revealed by even the slightest change in the environment. Slight convex and concave warps, both horizontal and vertical, occurred, bringing the danger of more splitting. With great reluctance a decision was made to remove the two vertical and three horizontal battens, the former being certainly part of the original construction, and the latter probably original as well. The battens also prevented proper treatment of some of the splits and of the fracture which ran all the way up the right edge (see Fig.8).

Figs 13,14 and 15 show the back of the panel after the battens had been removed. Although the removal of part of an original panel construction is very much a last resort, it was thought to be justified in this instance. Had the battens been allowed to remain in position, it is likely that the panel would still have been inordinately sensitive, whatever form of protection or reinforcement had been applied to the back.
